Bald Mountain Fire Lookout's Cabin

Willoughby State Forest- Westmore, VT
September 9- October 4, 2013

Bald Mountain Cabin, constructed c. 1922

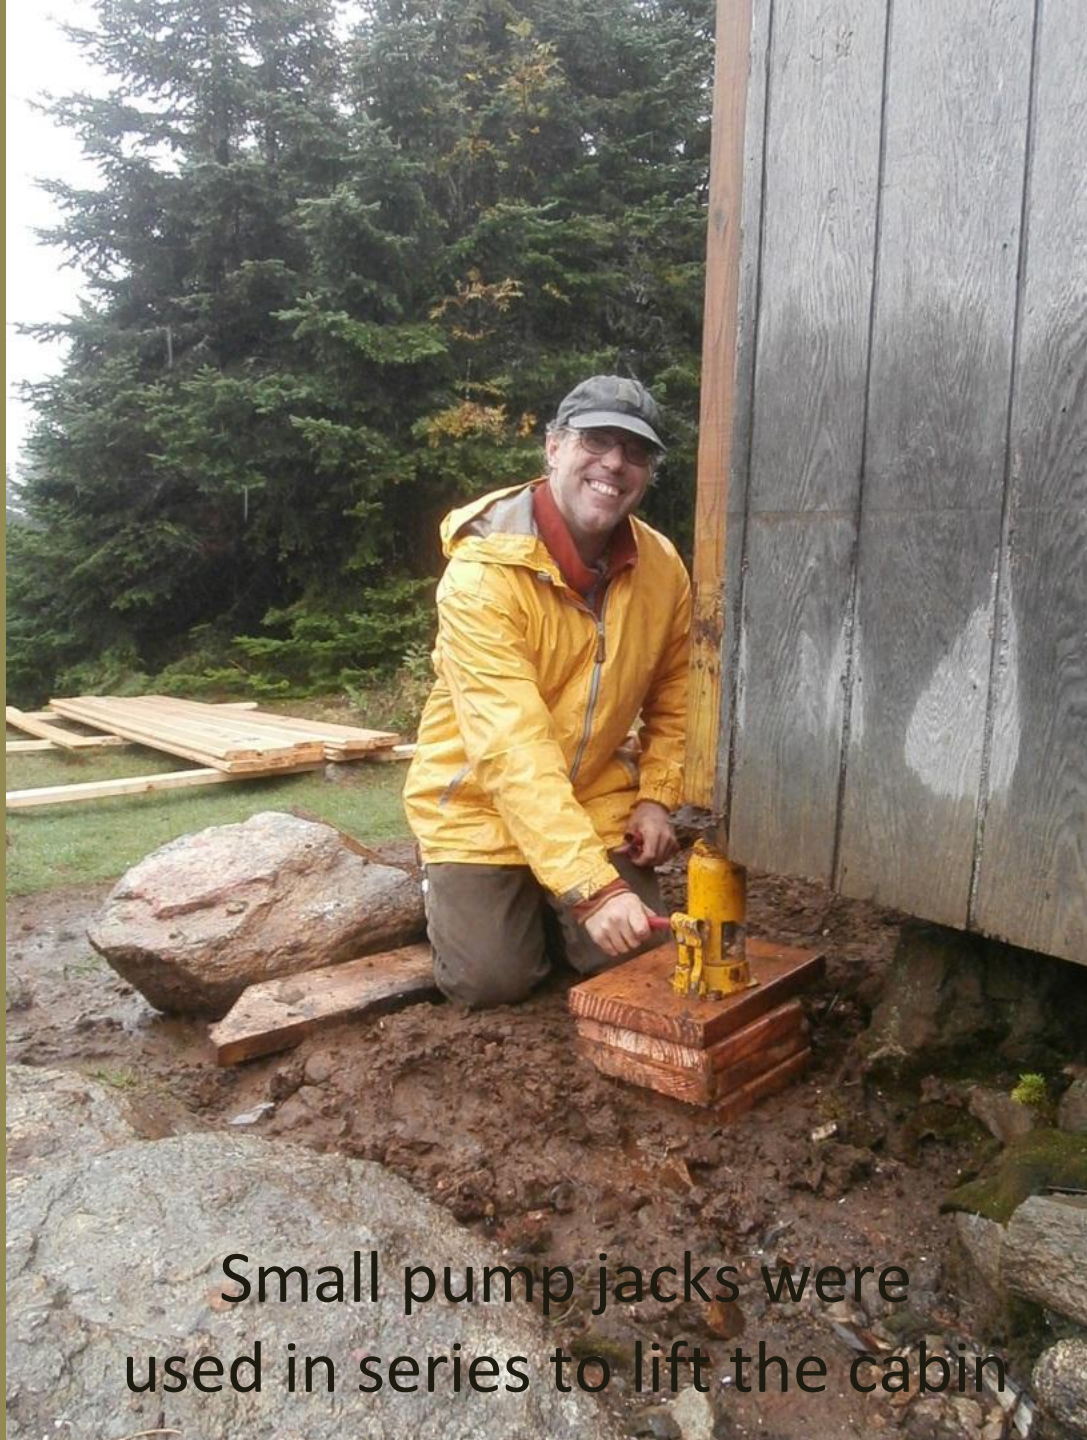
Small pump jacks were used in series to lift the cabin

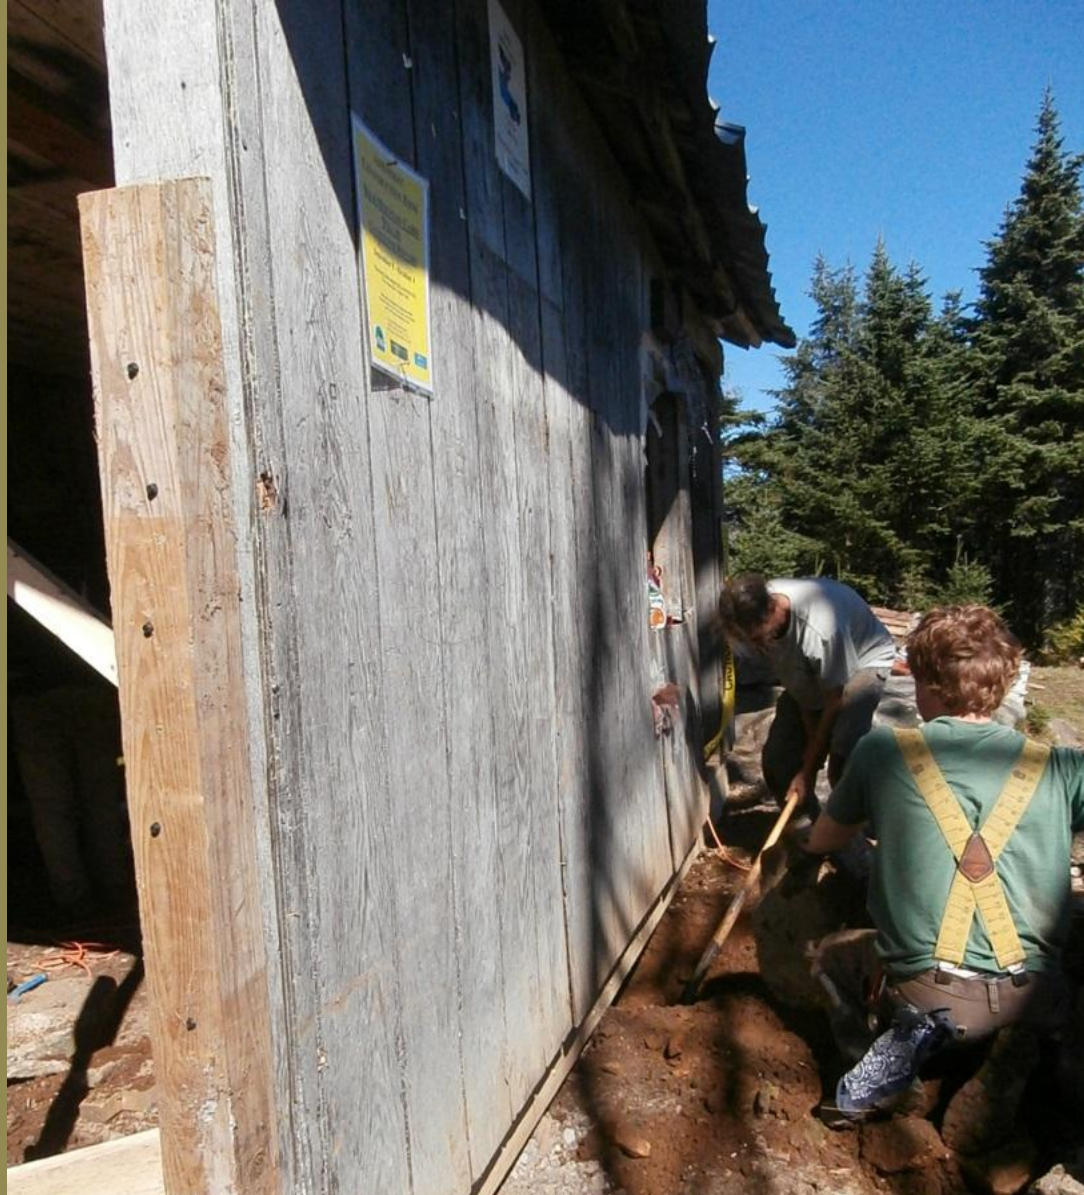
The entire perimeter was cleared and excavated to set new sills

Studs were replaced or reinforced
on top of a new bottom plate

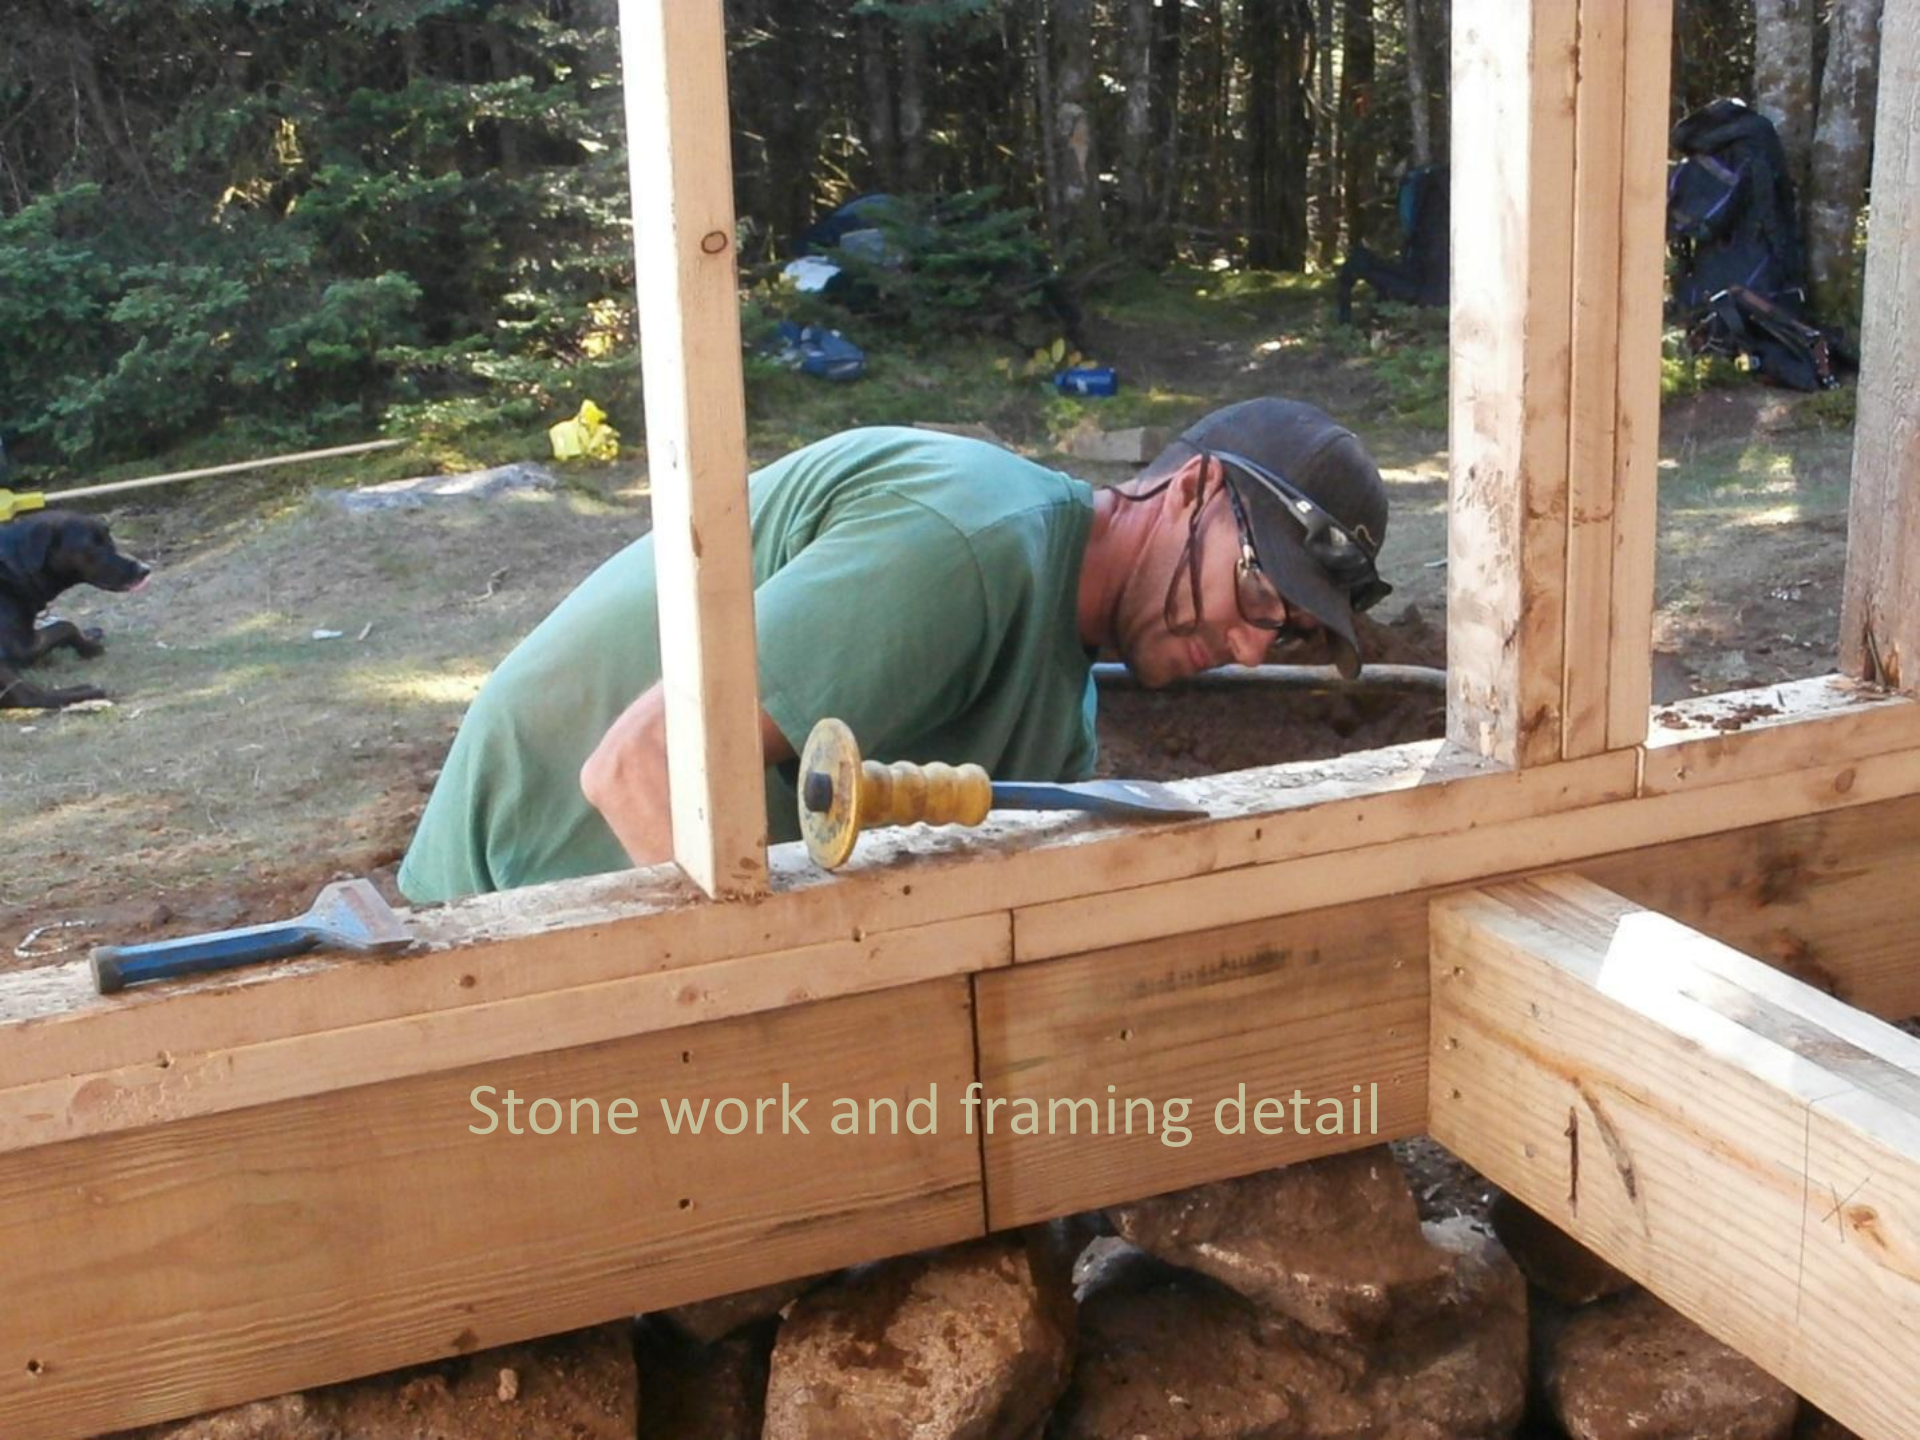
Stone work and framing detail

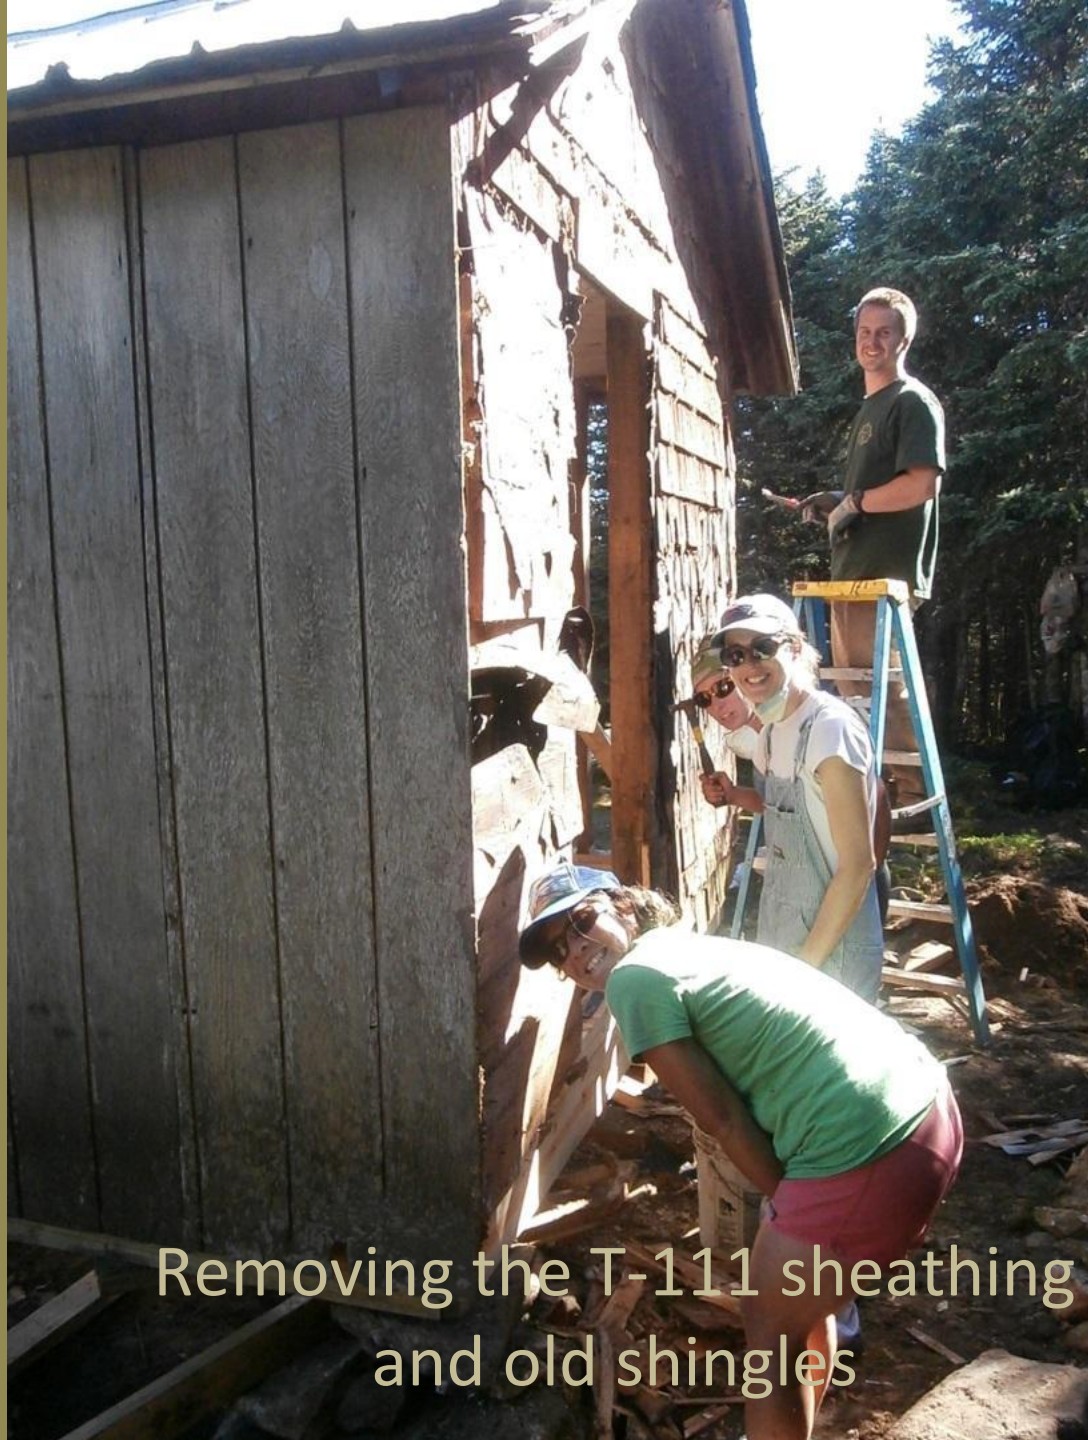
Removing the T-11 sheathing
and old shingles

Making a 'clean' work surface

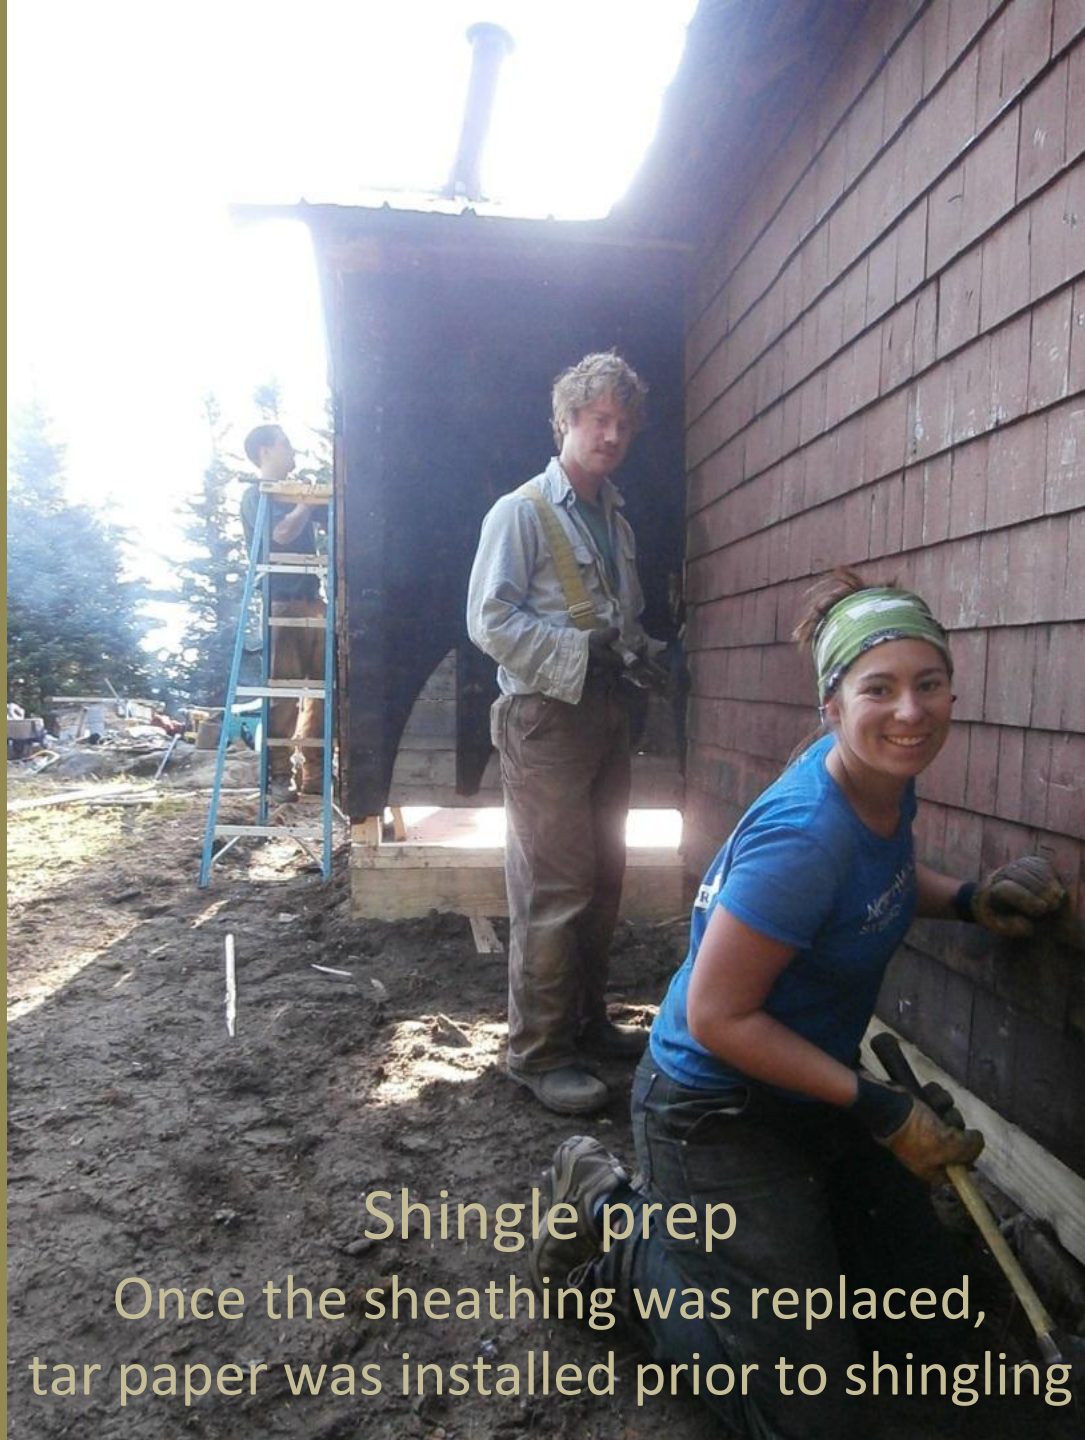
Once the sheathing was replaced, tar paper was installed prior to shingling

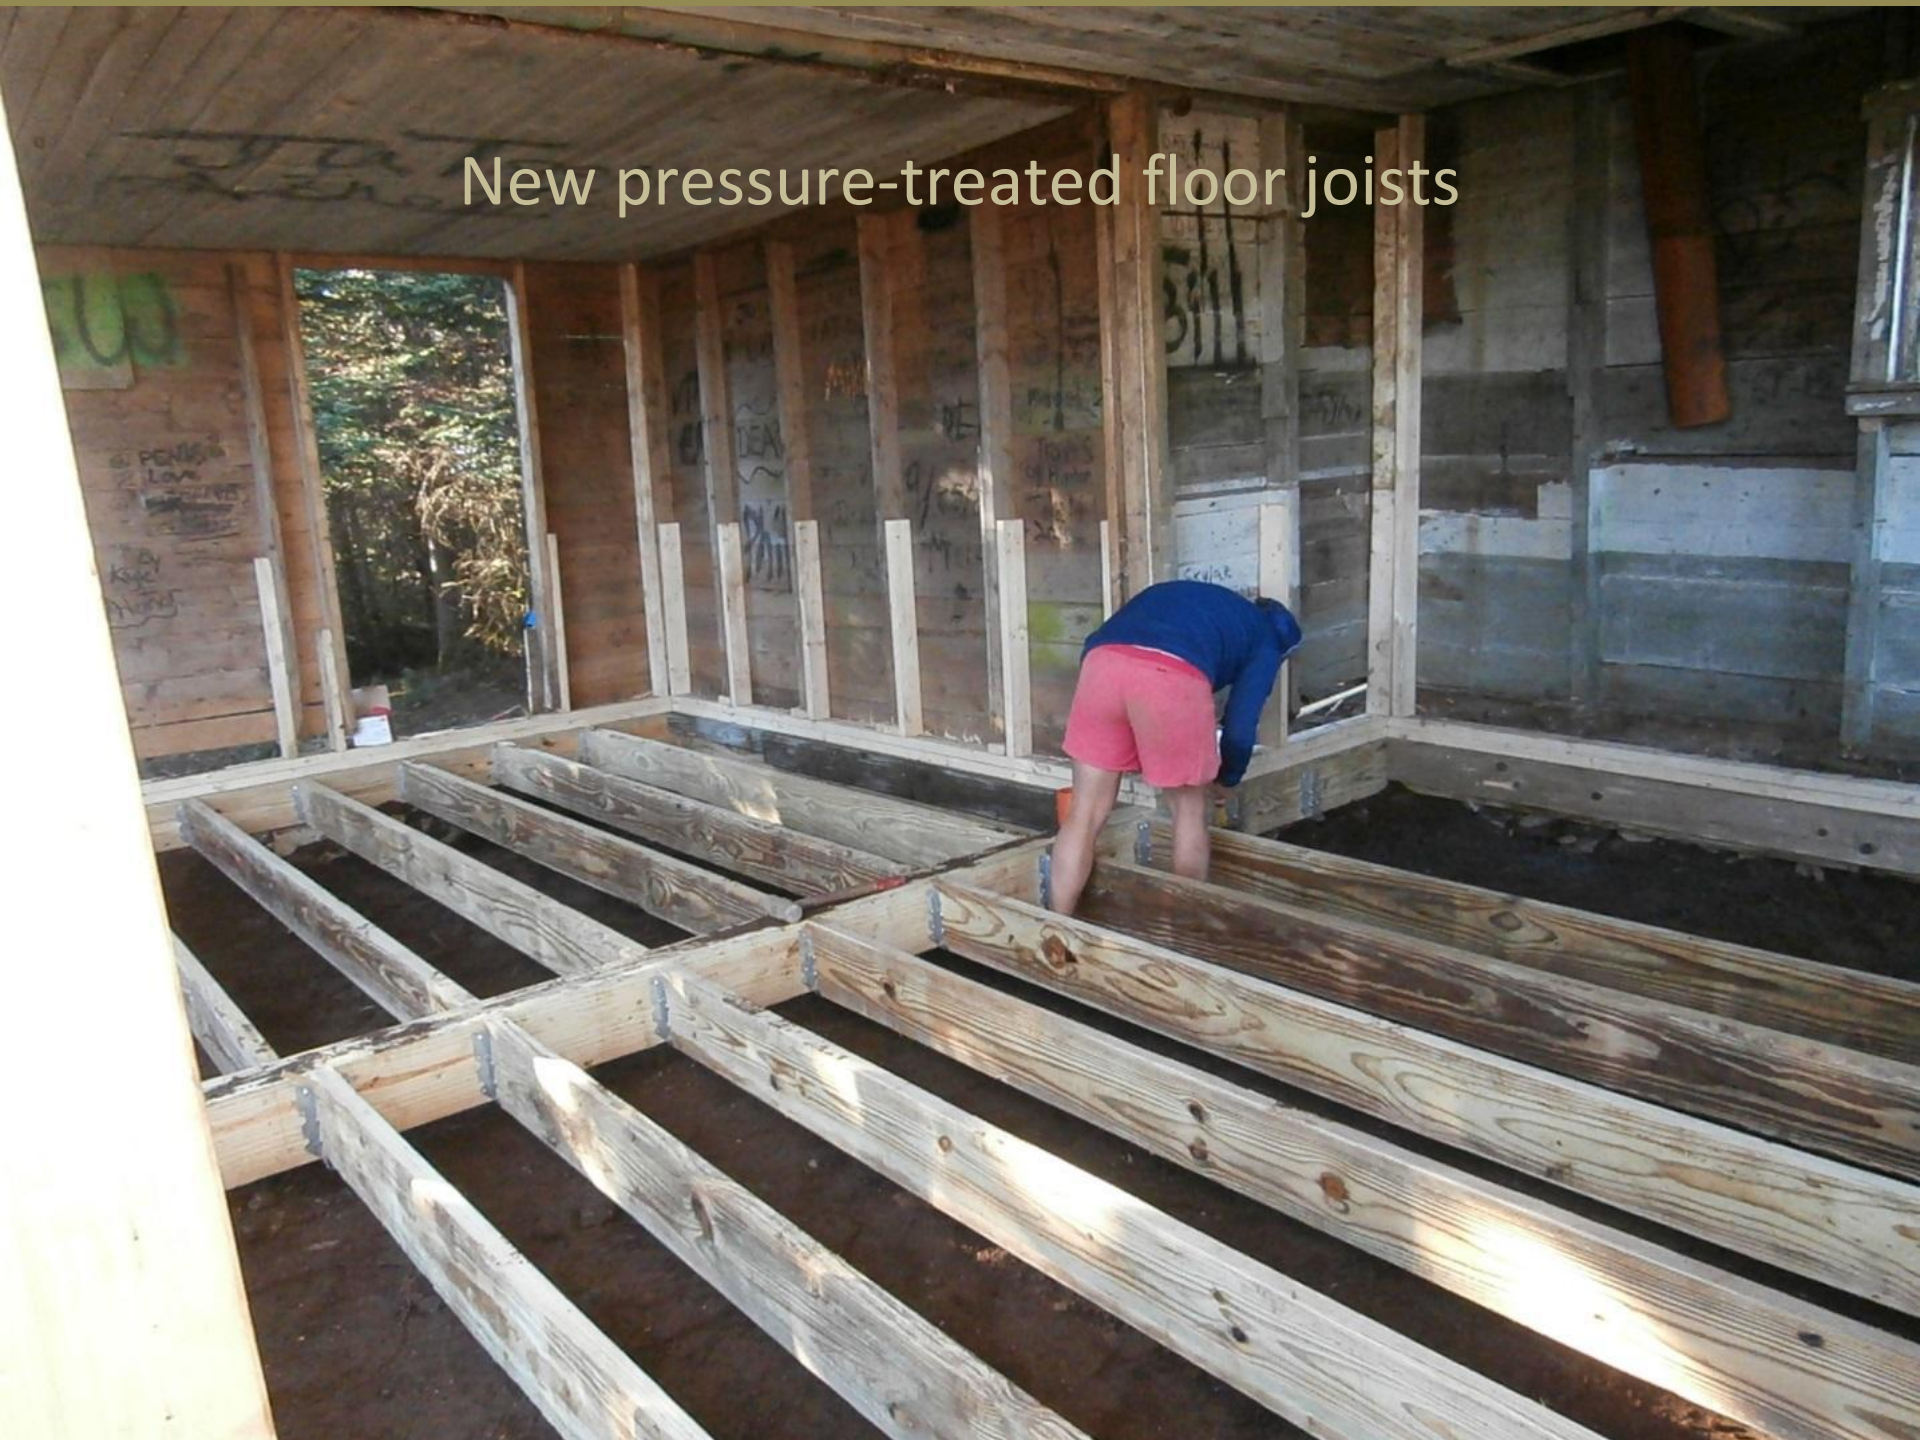
New 2-inch spruce/fir tongue and groove flooring

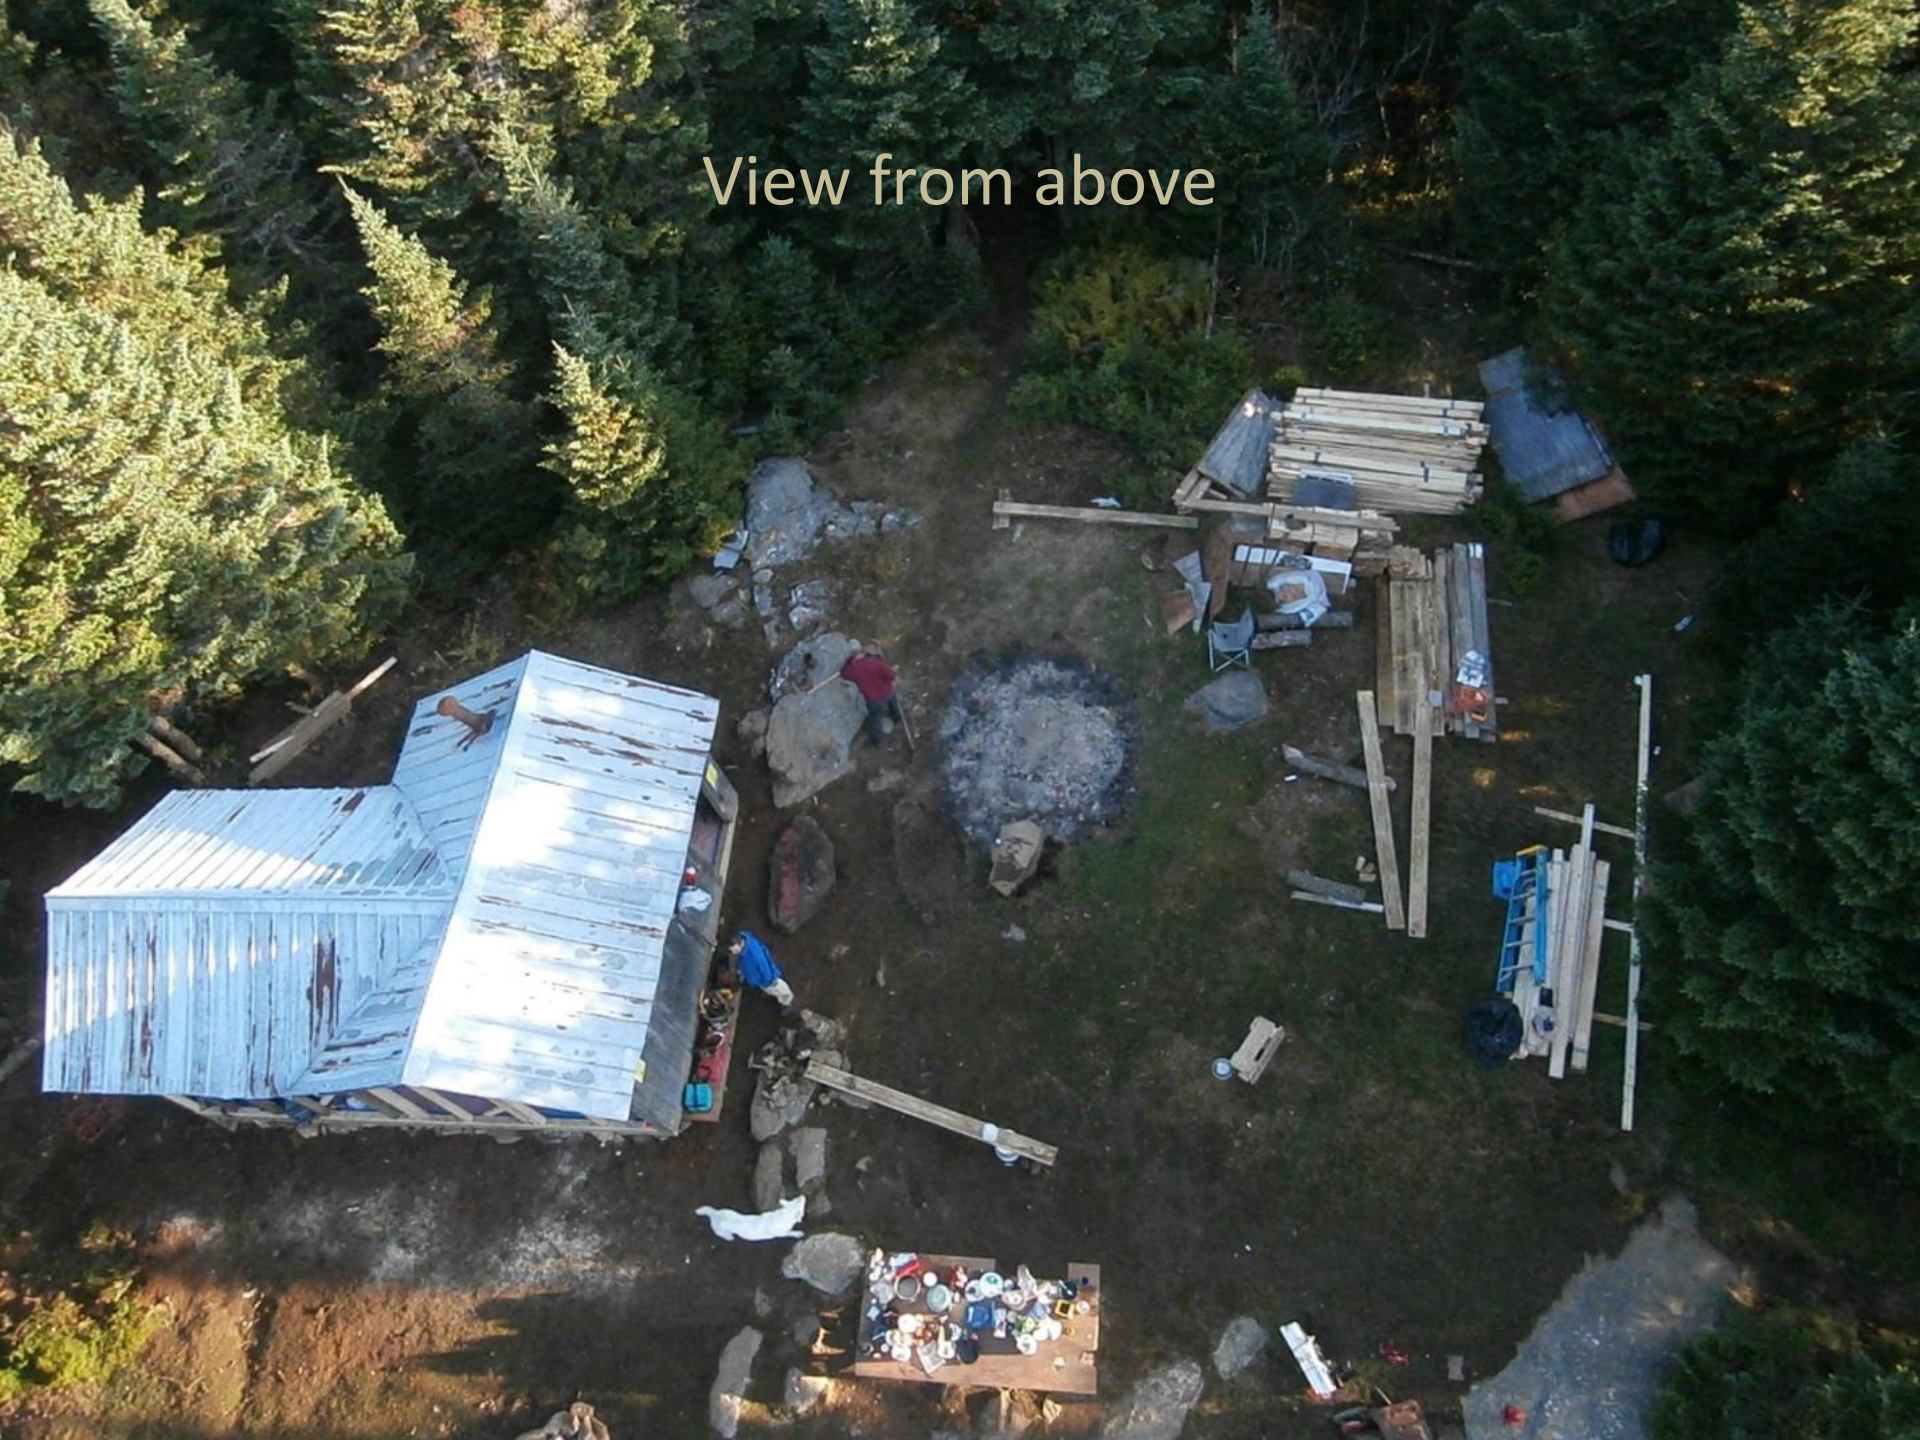
Interior walls ready for sheathing
(note floor paper to protect flooring)

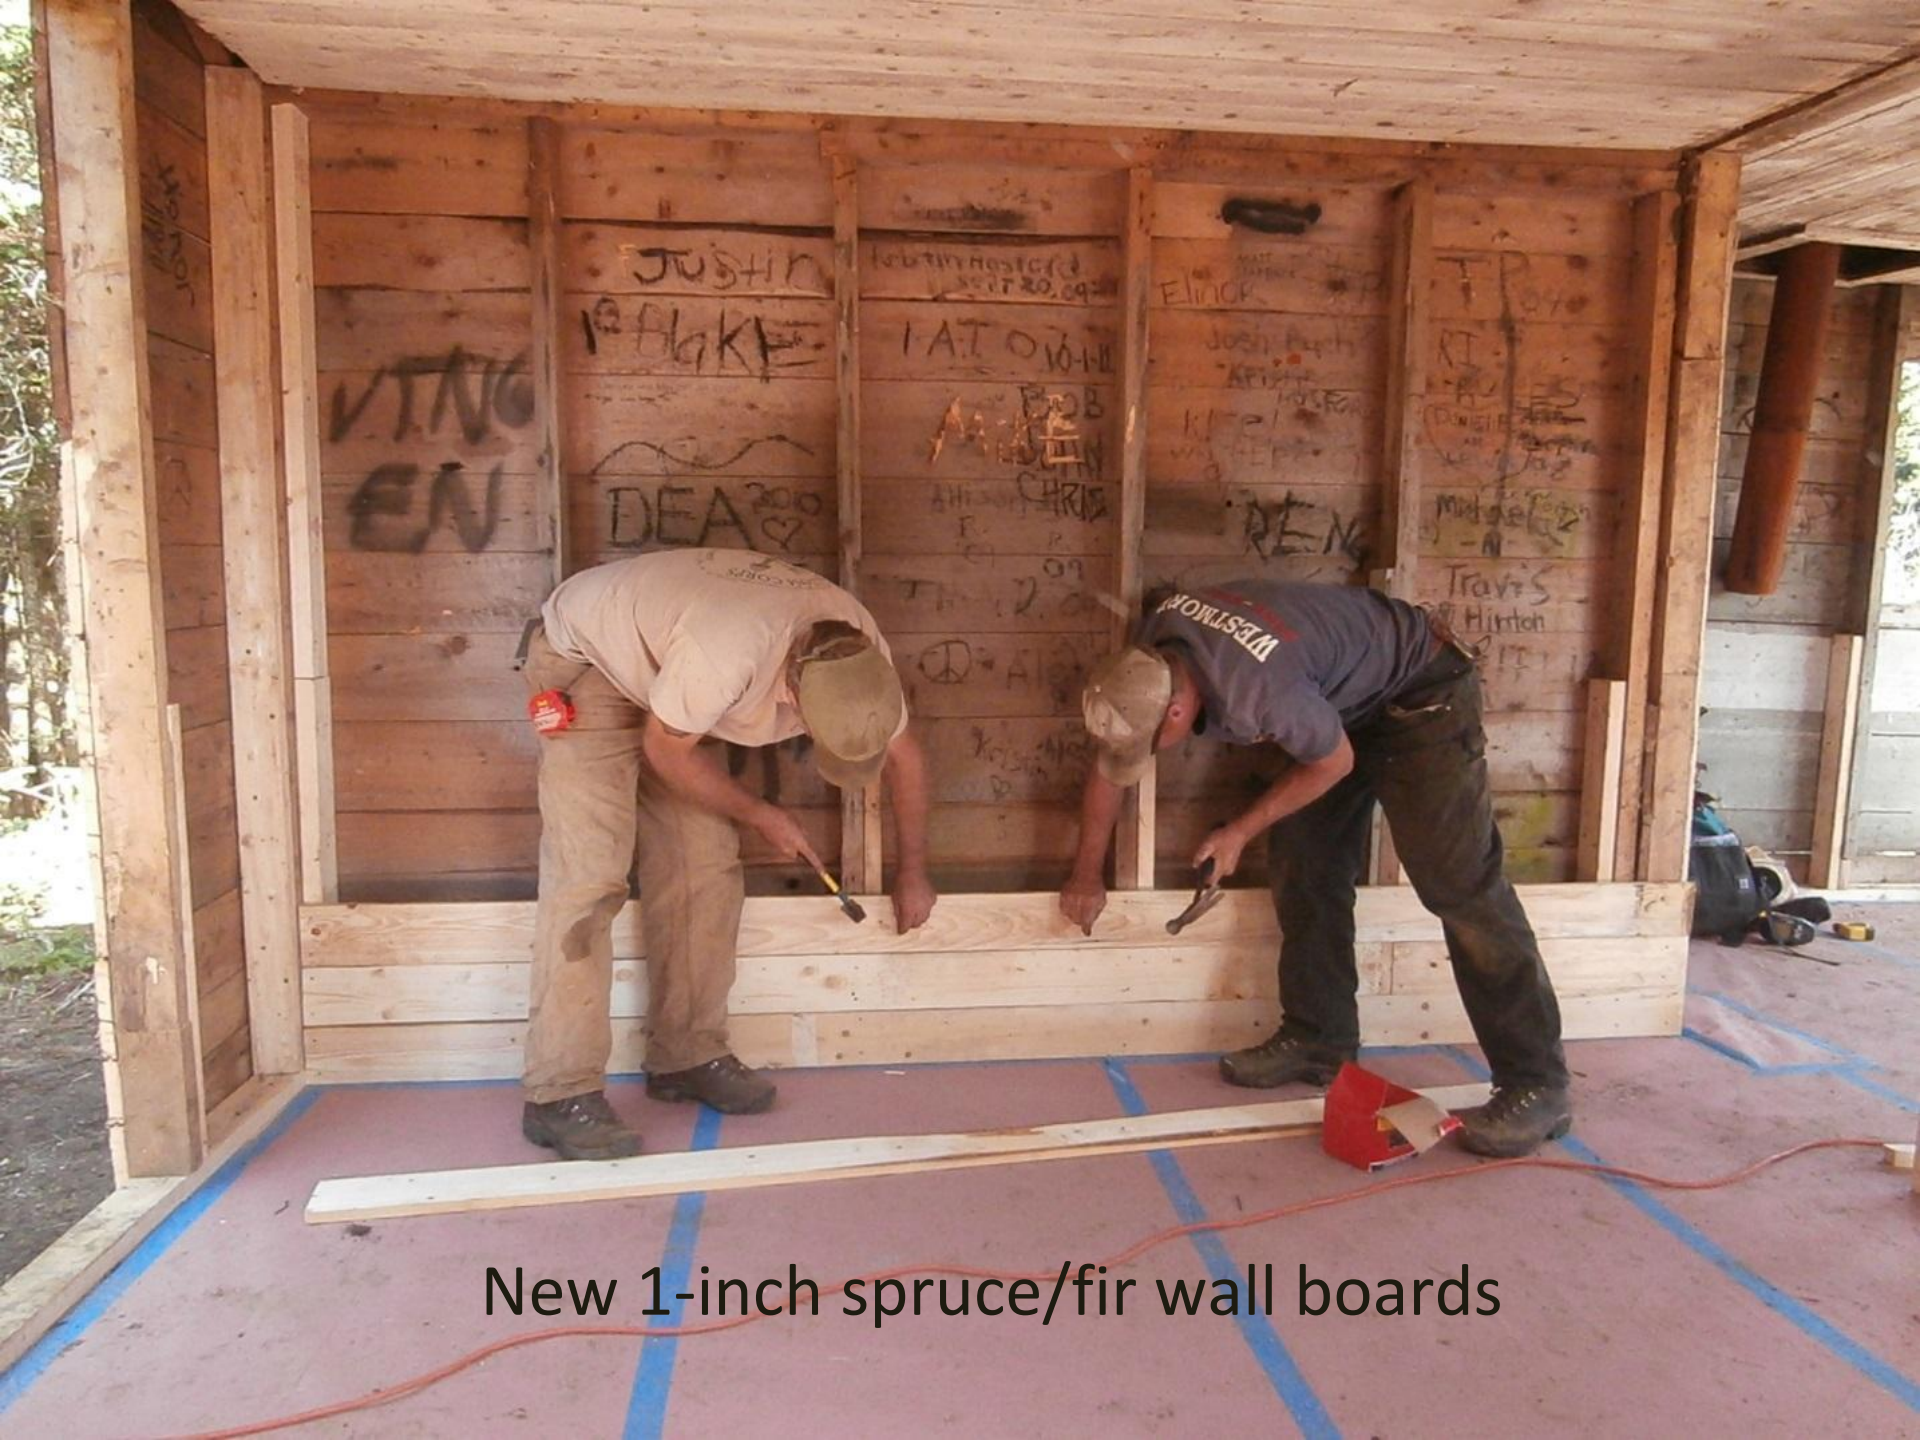
New 1-inch spruce/fir wall boards

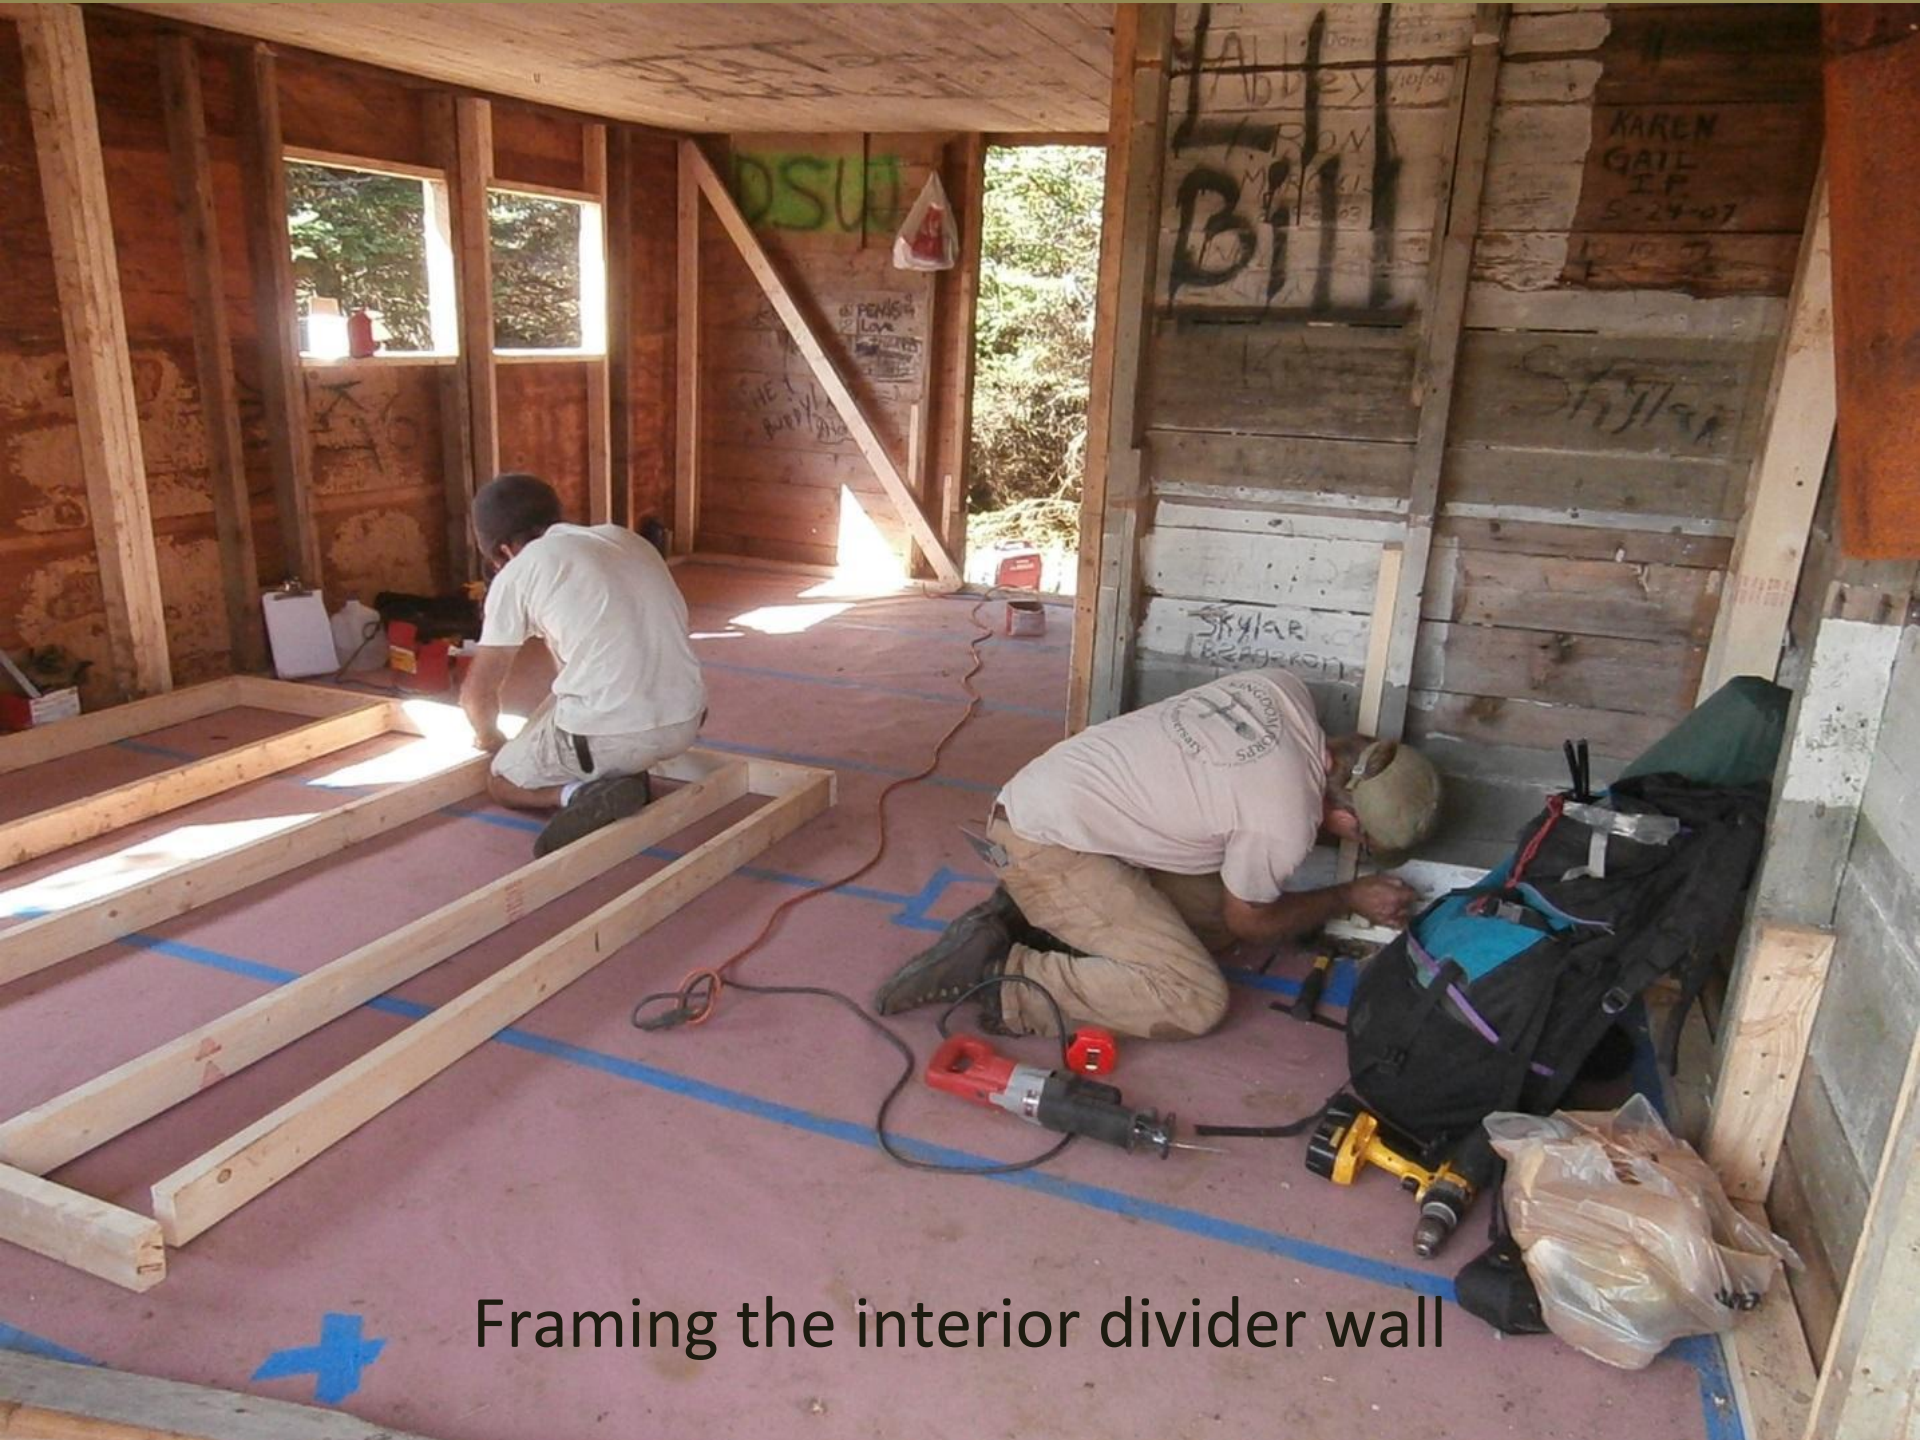
Framing the interior divider wall

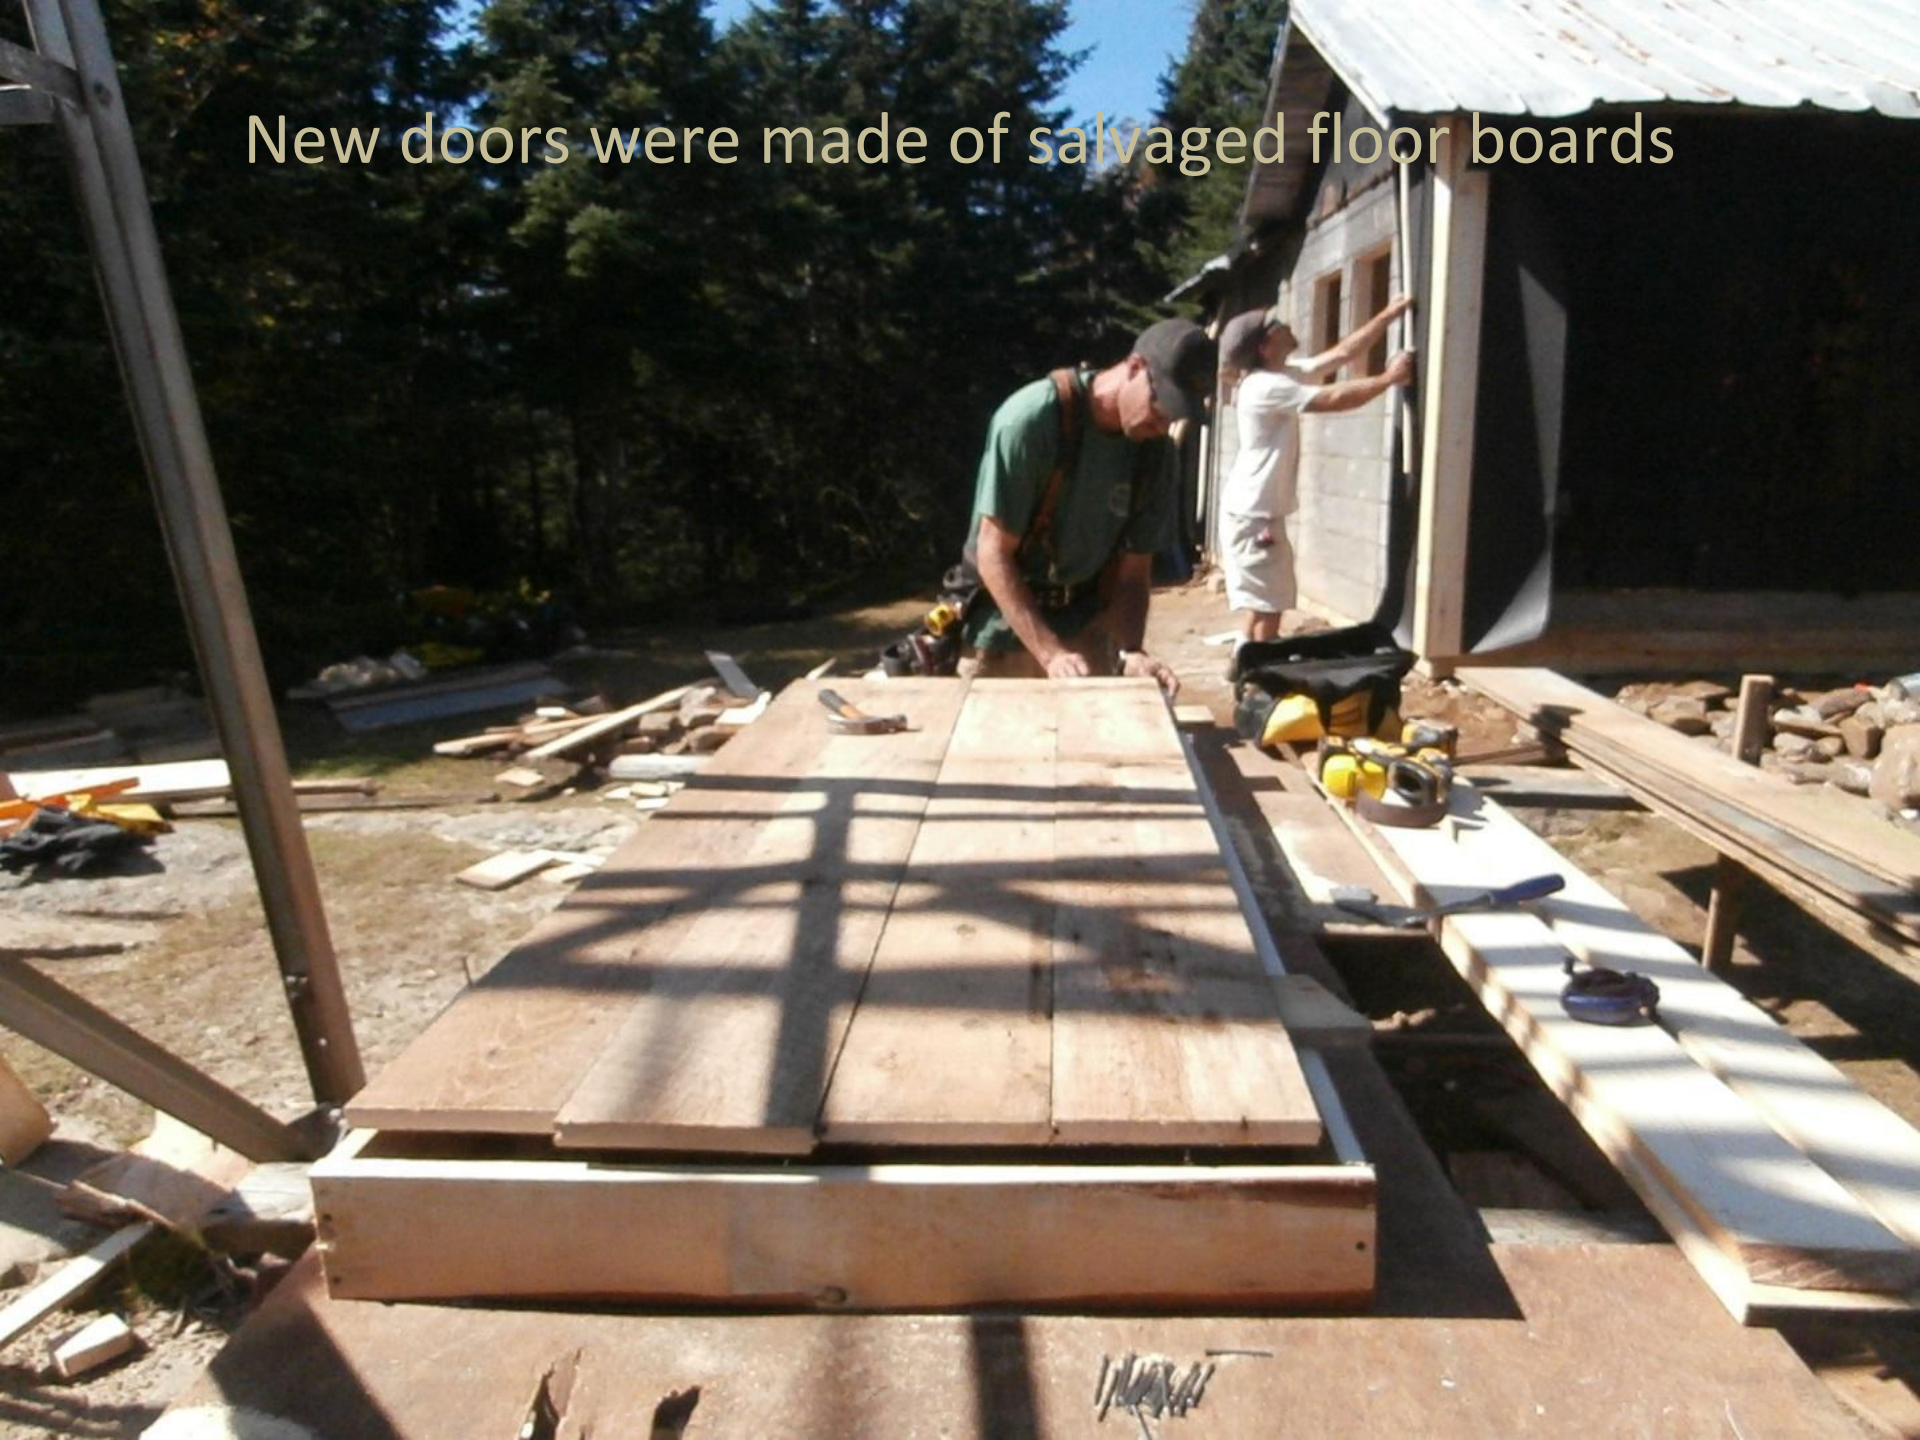
New doors were made of salvaged floor boards
