Bald Mountain Fire Lookout's Cabin

Willoughby State Forest- Westmore, VT
September 9- October 4, 2013

Bald Mountain Cabin, constructed c. 1922

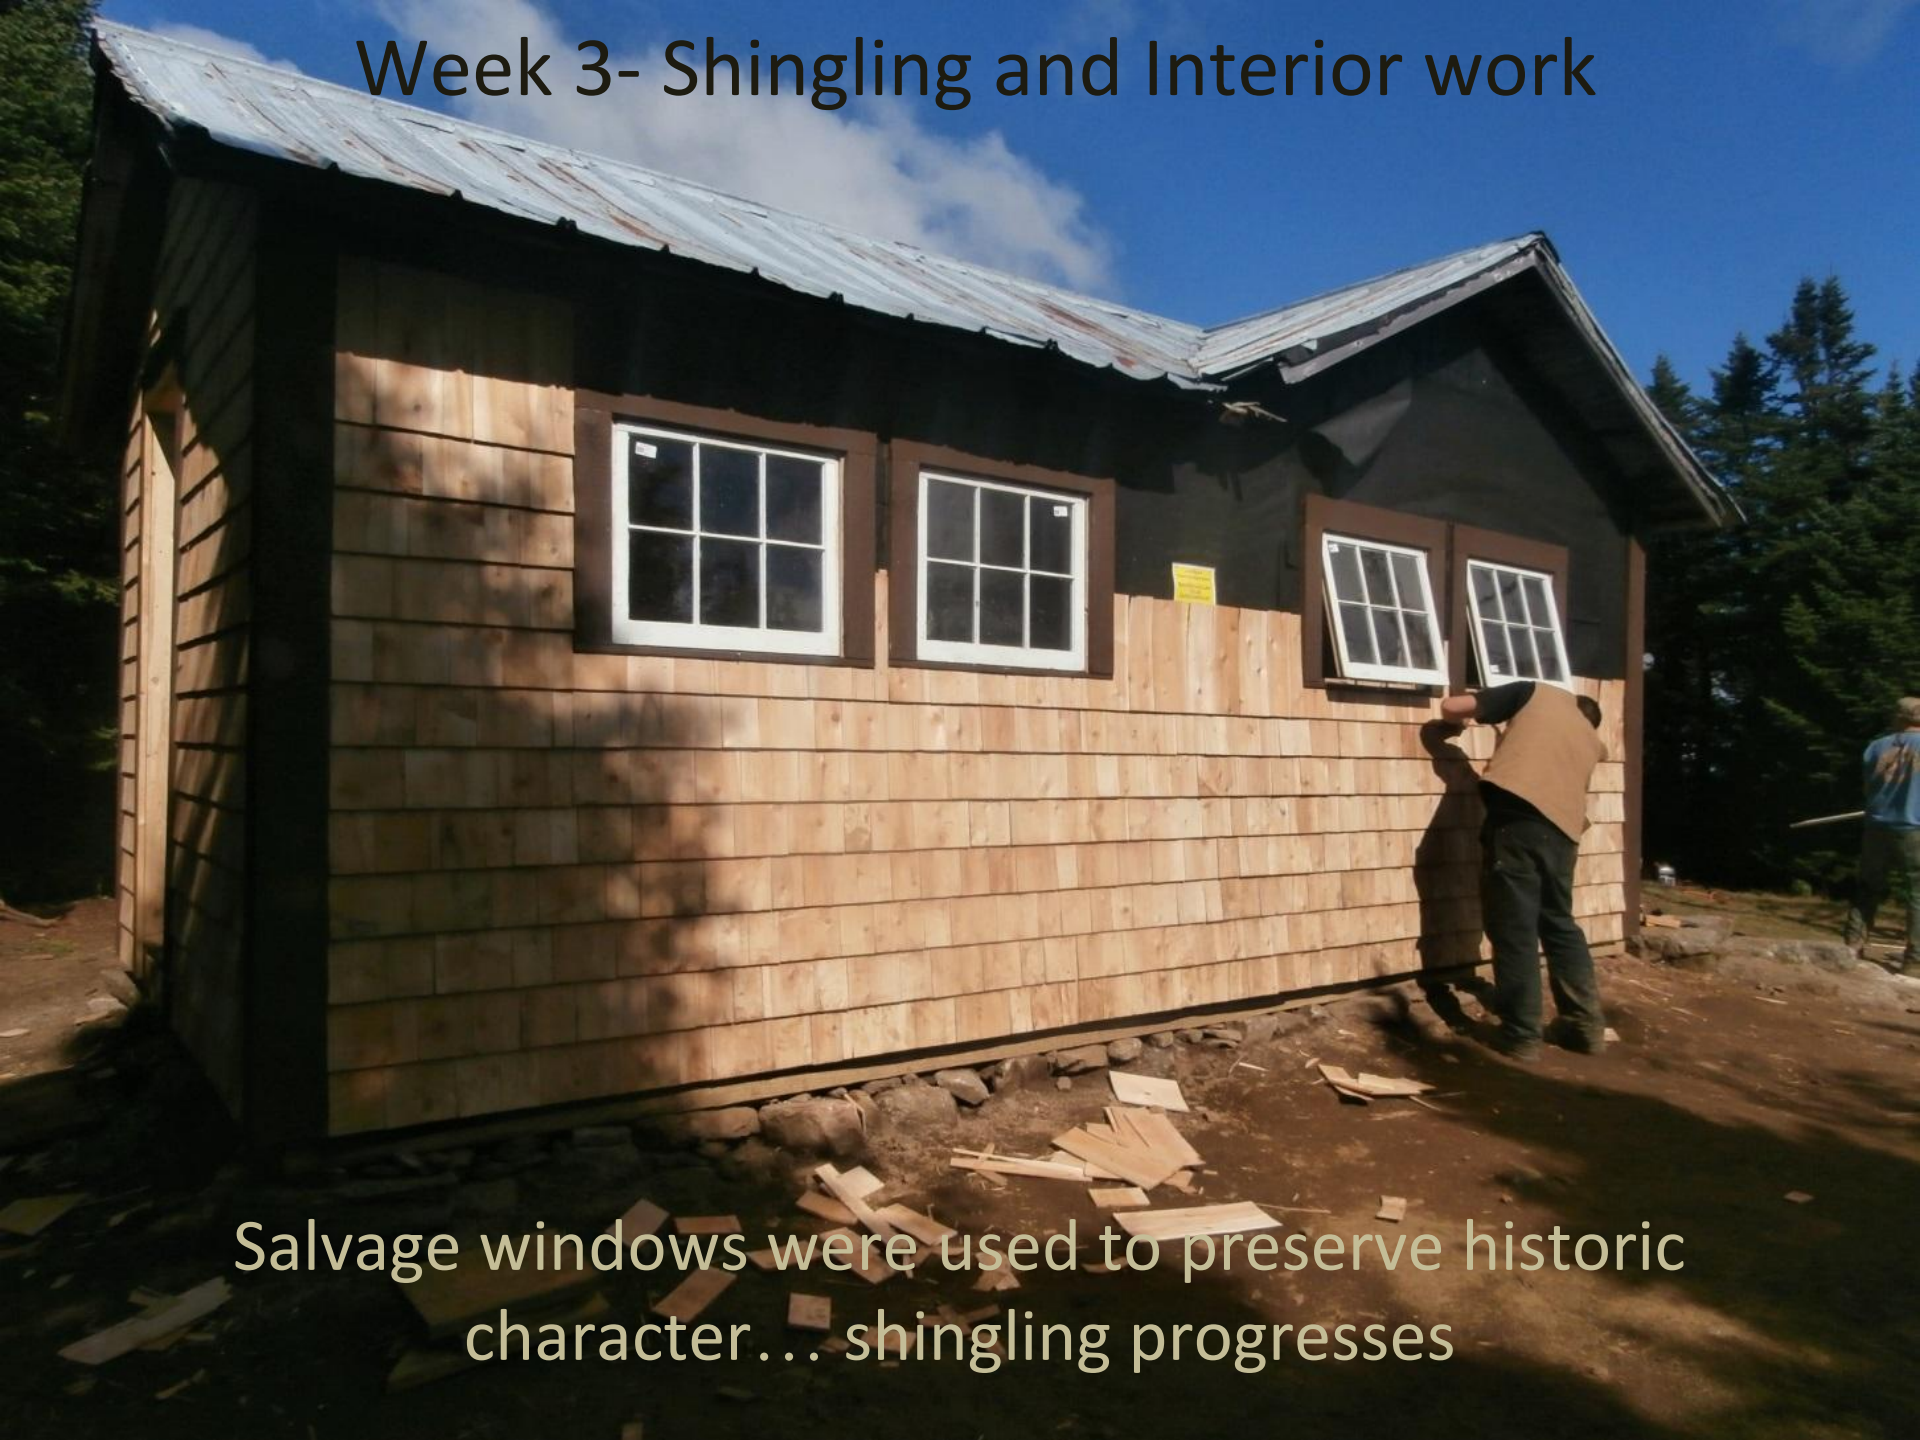
Salvage windows were used to preserve historic character... shingling progresses

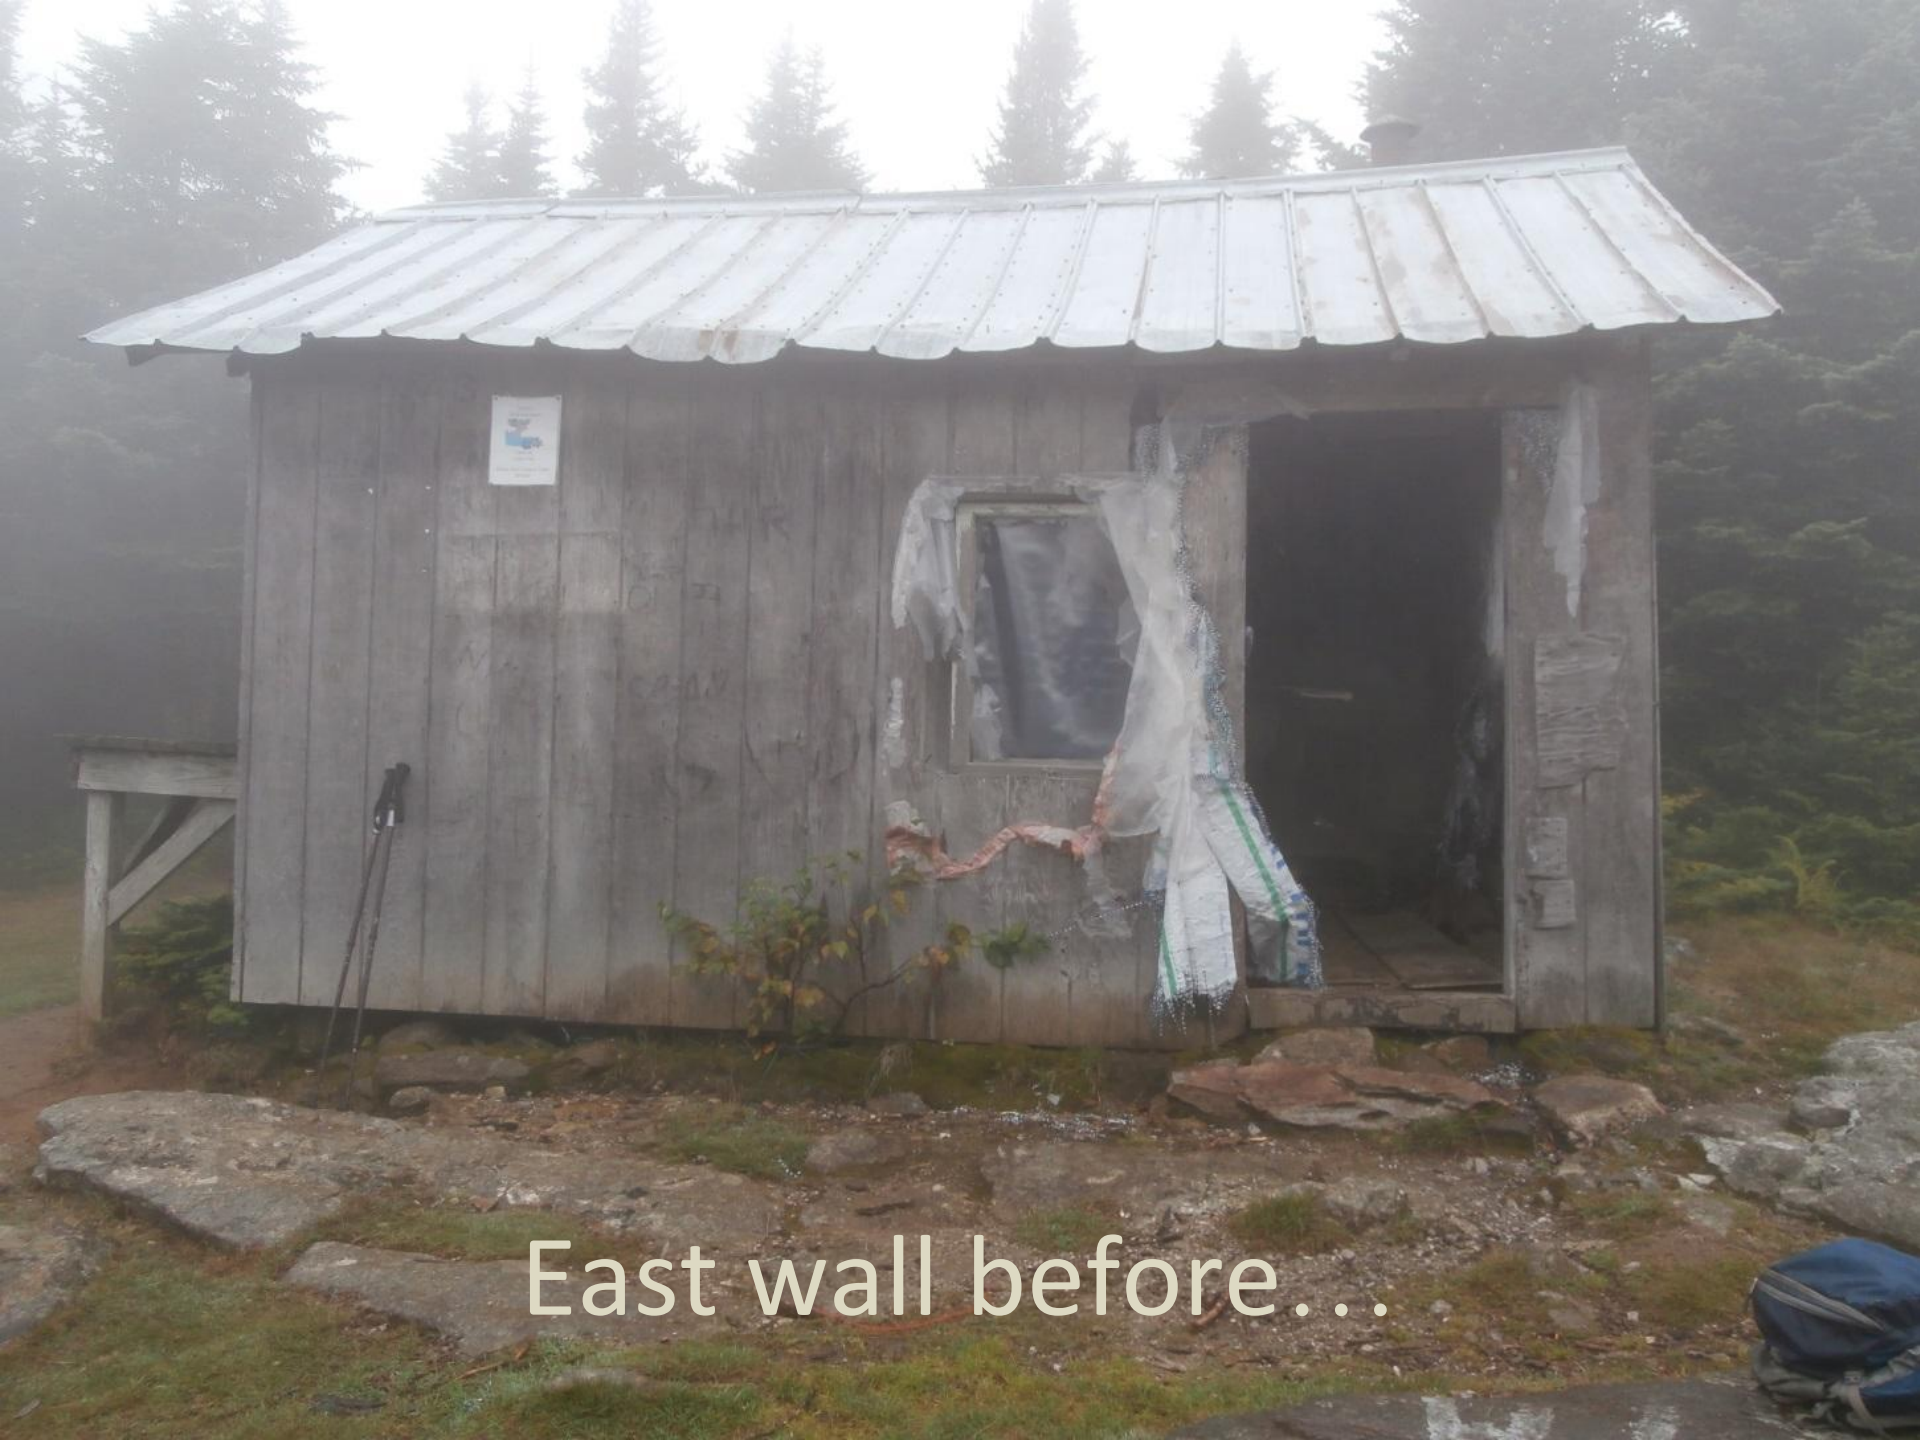
East wall before...

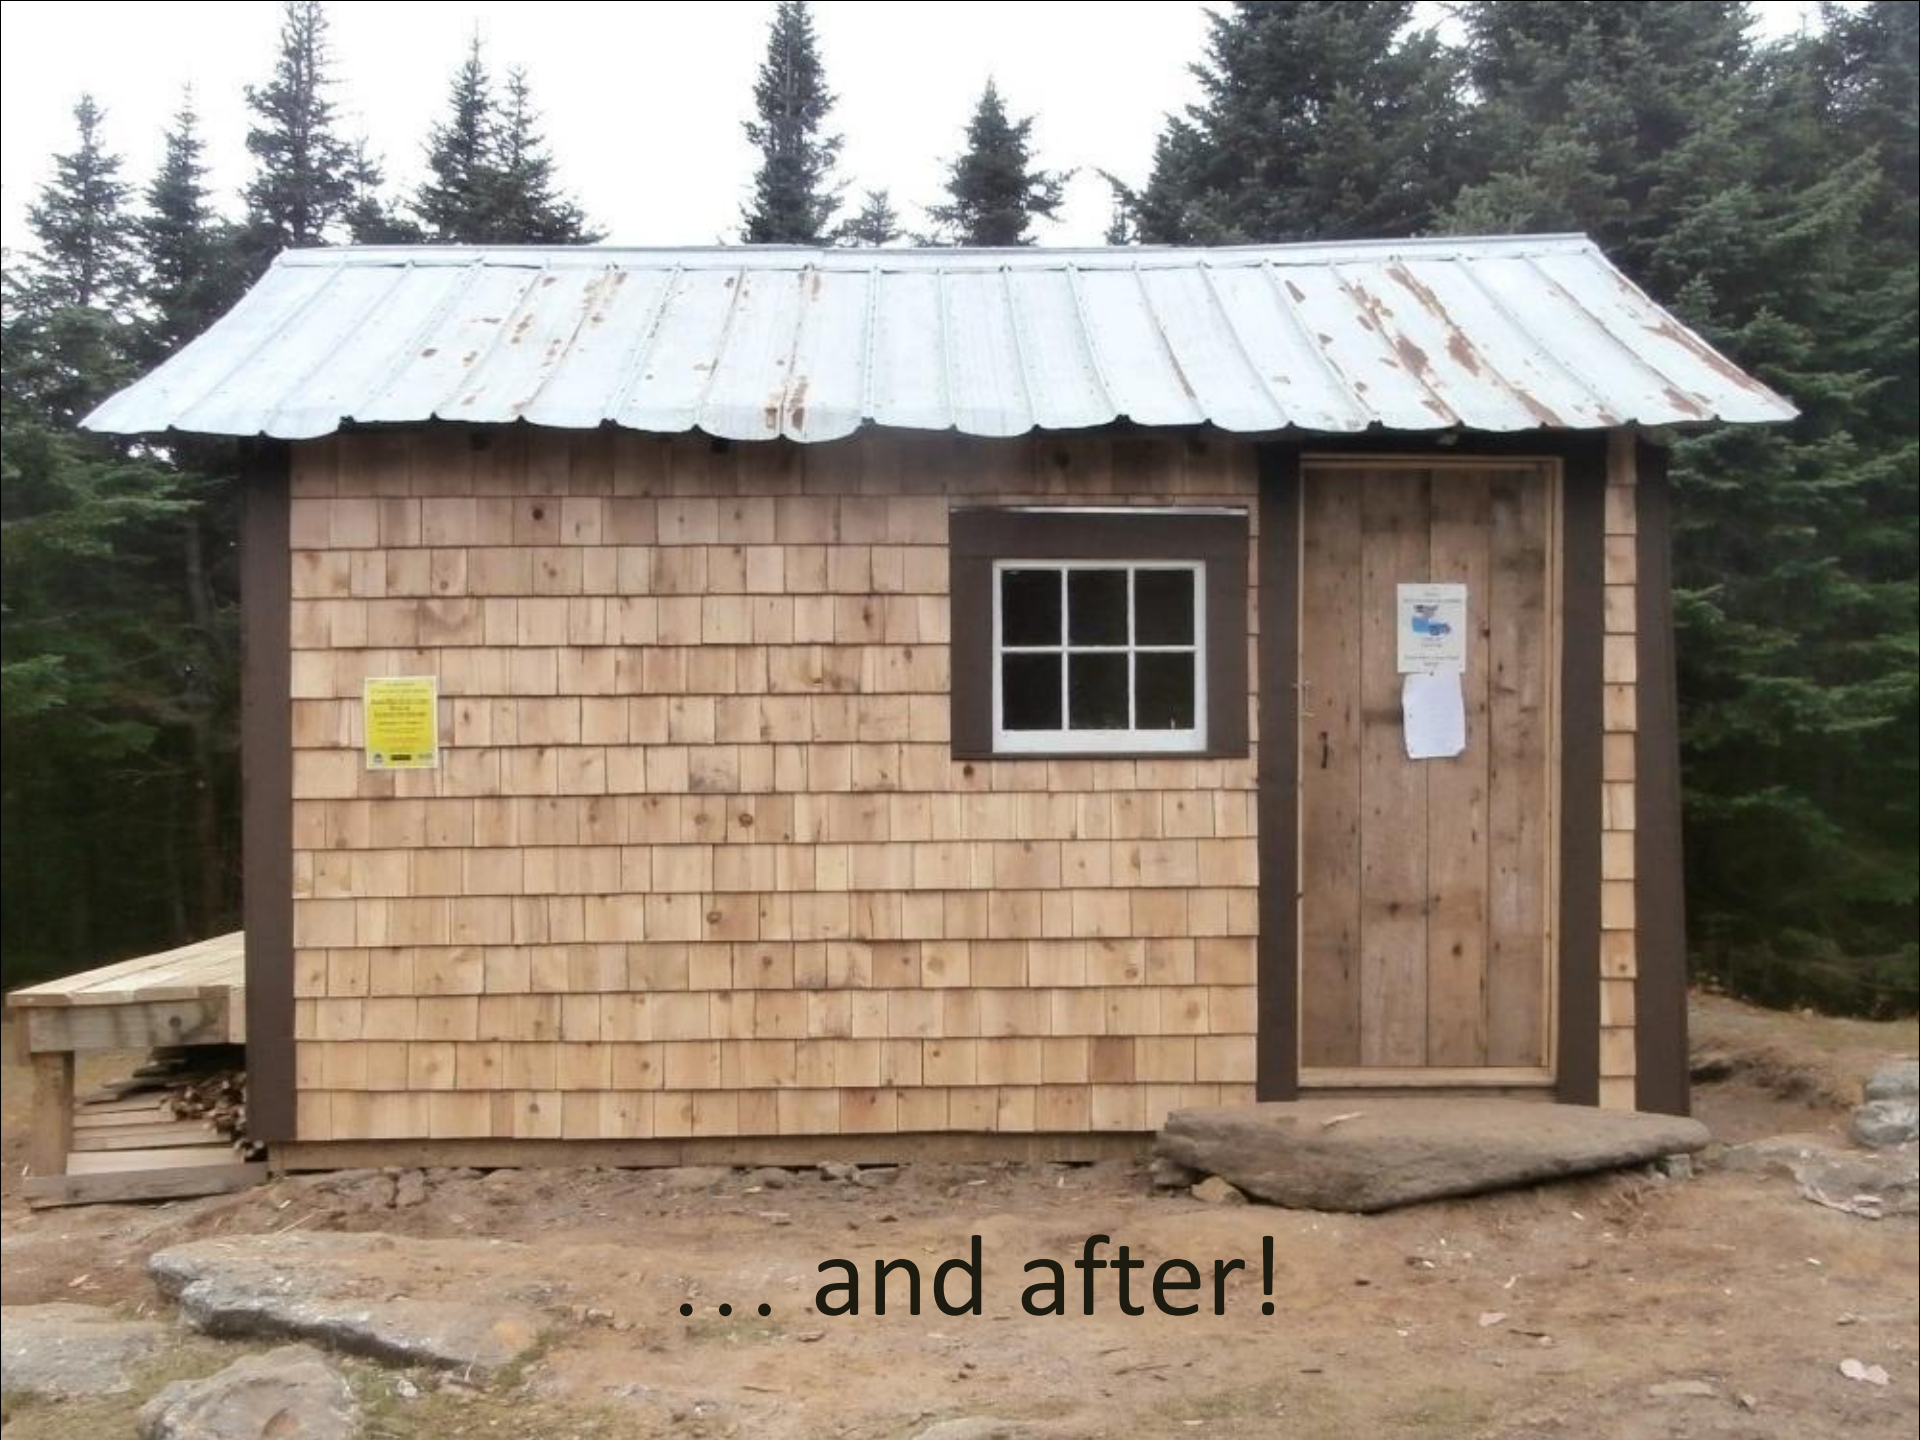
... and after!

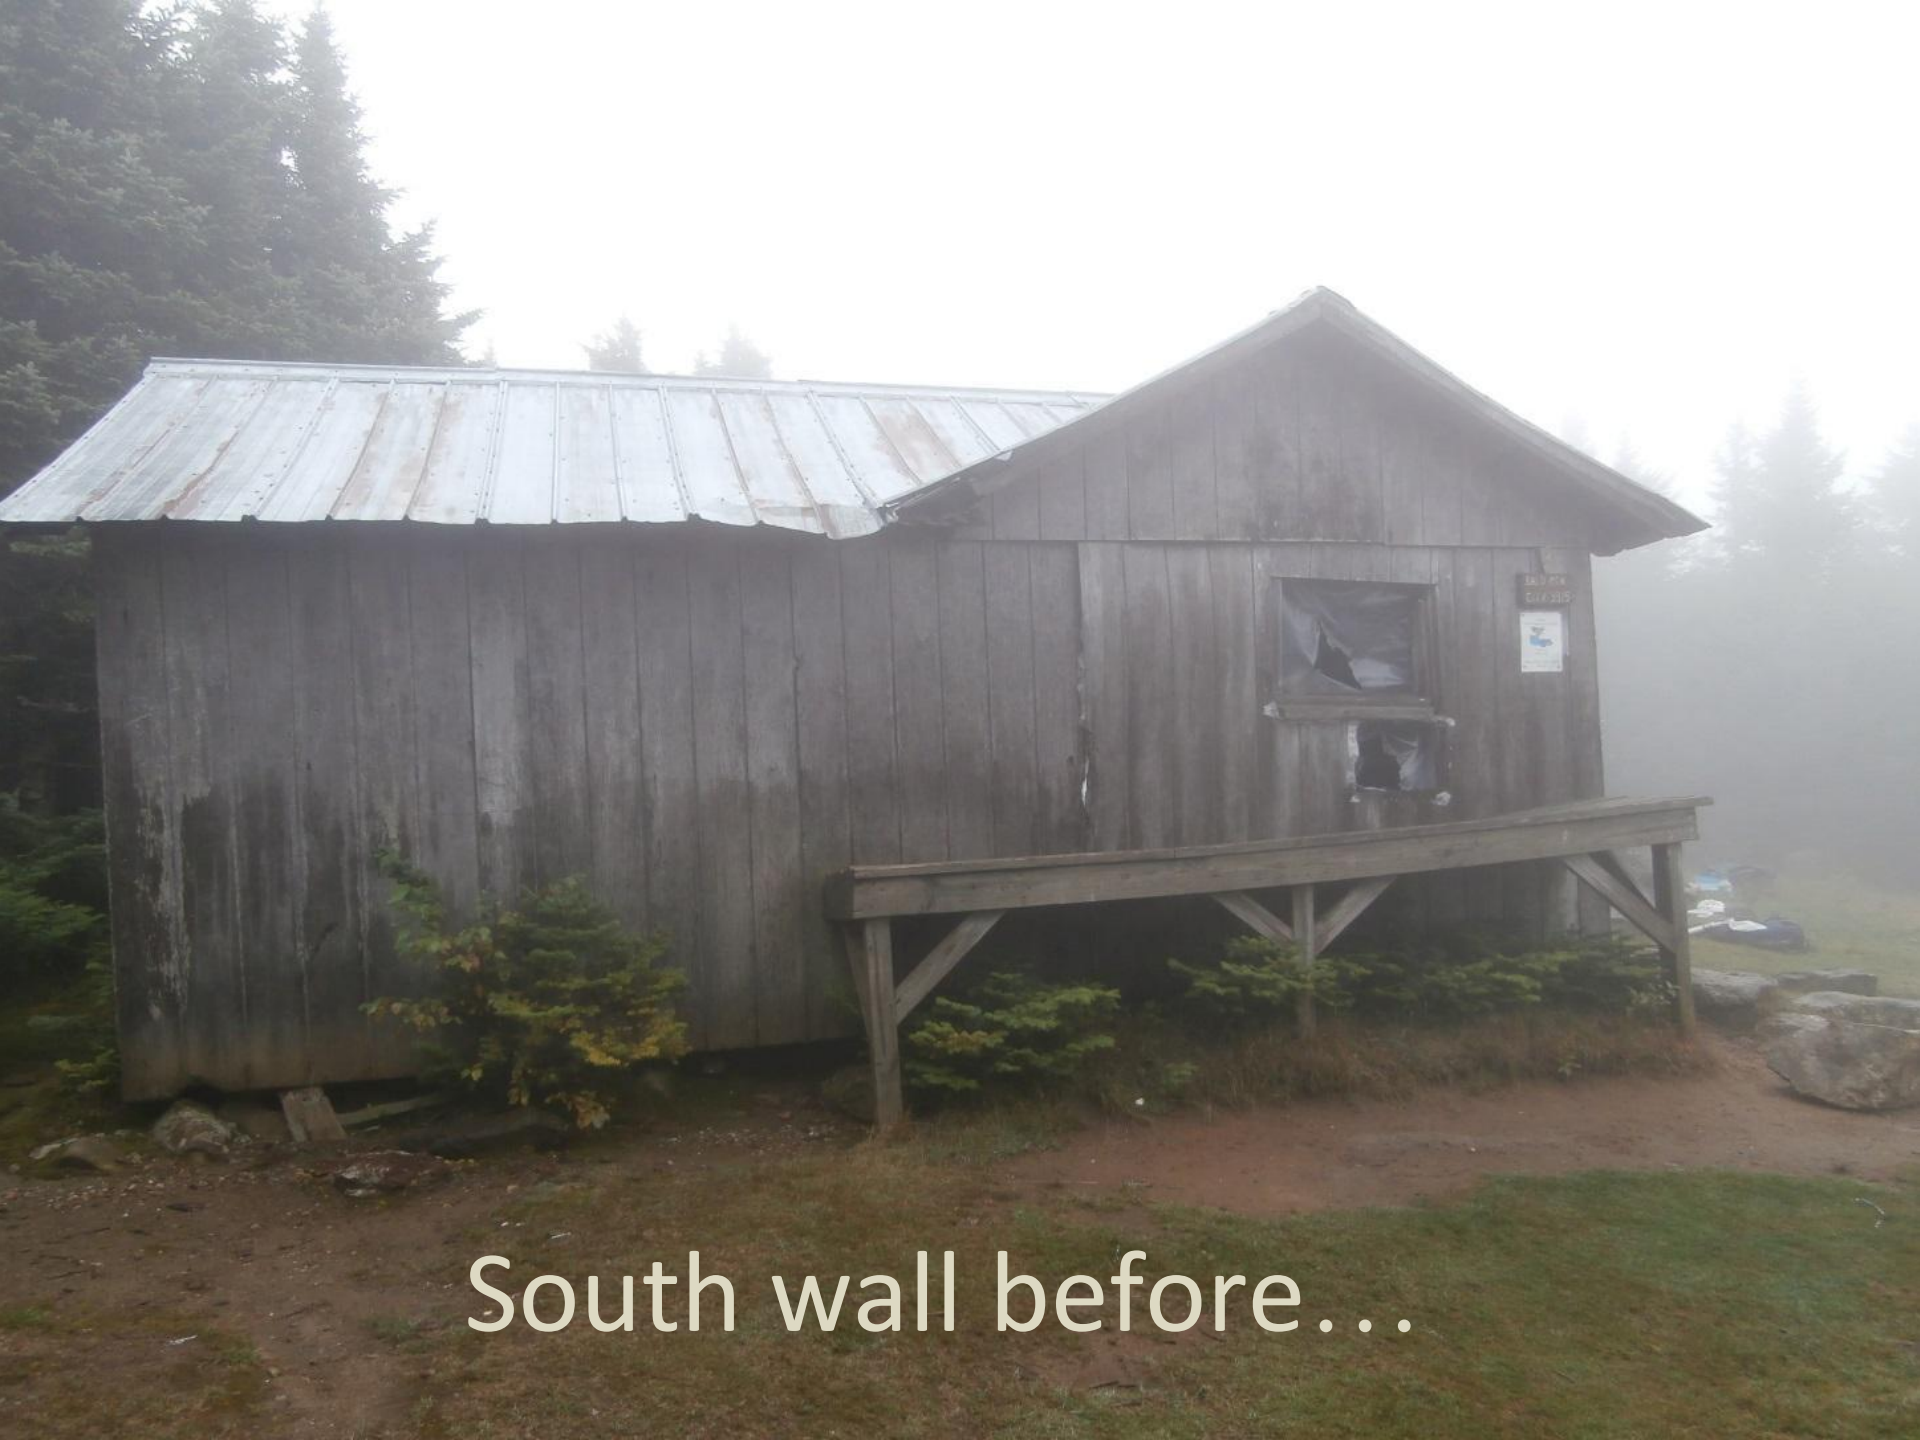
South wall before...

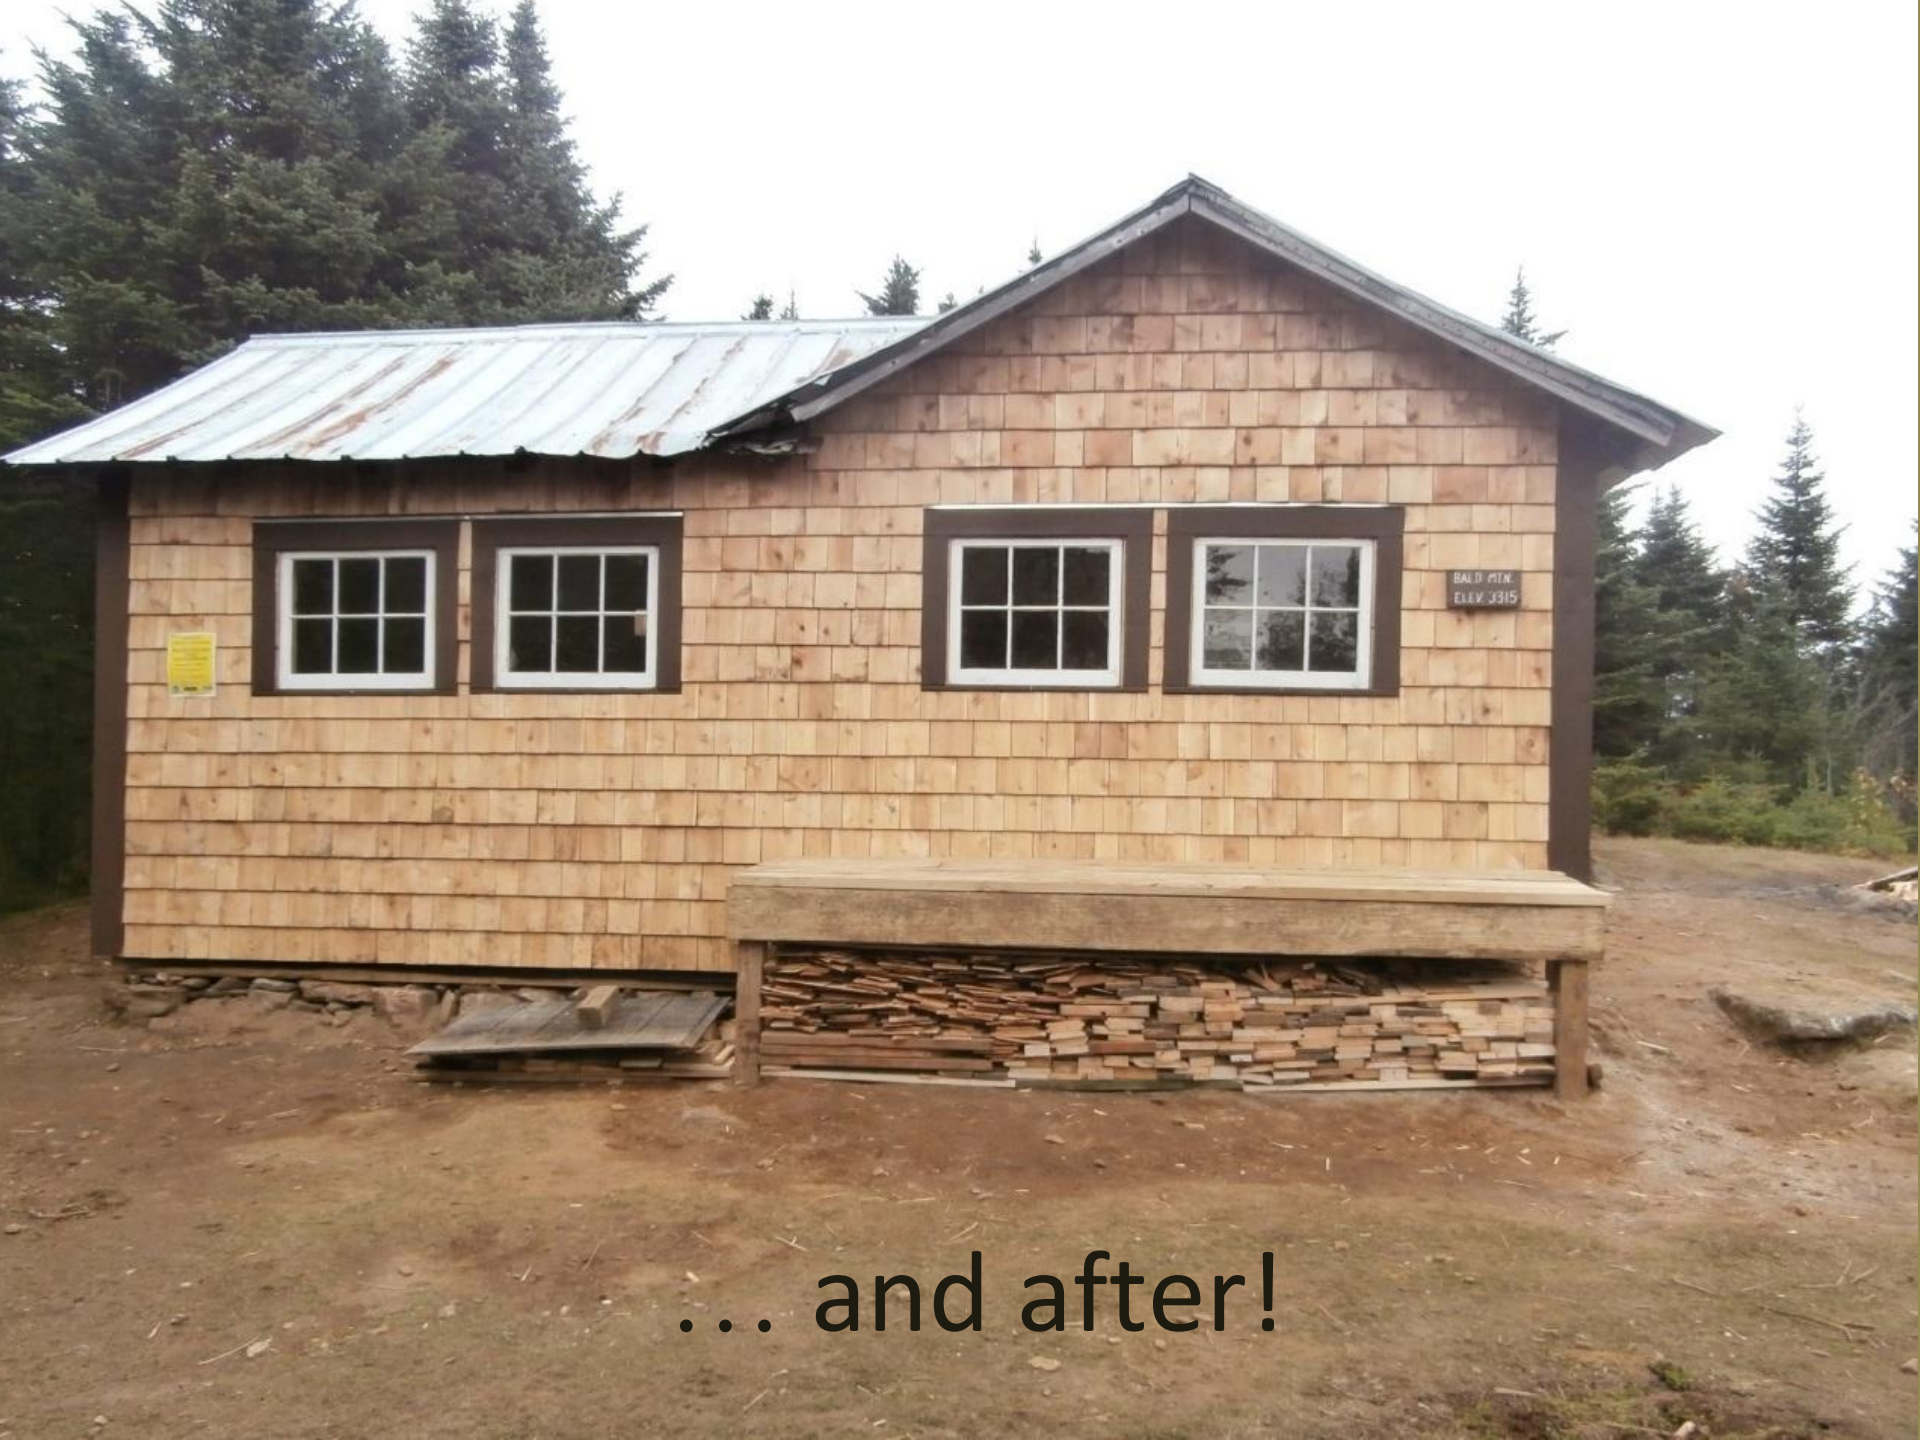
... and after!

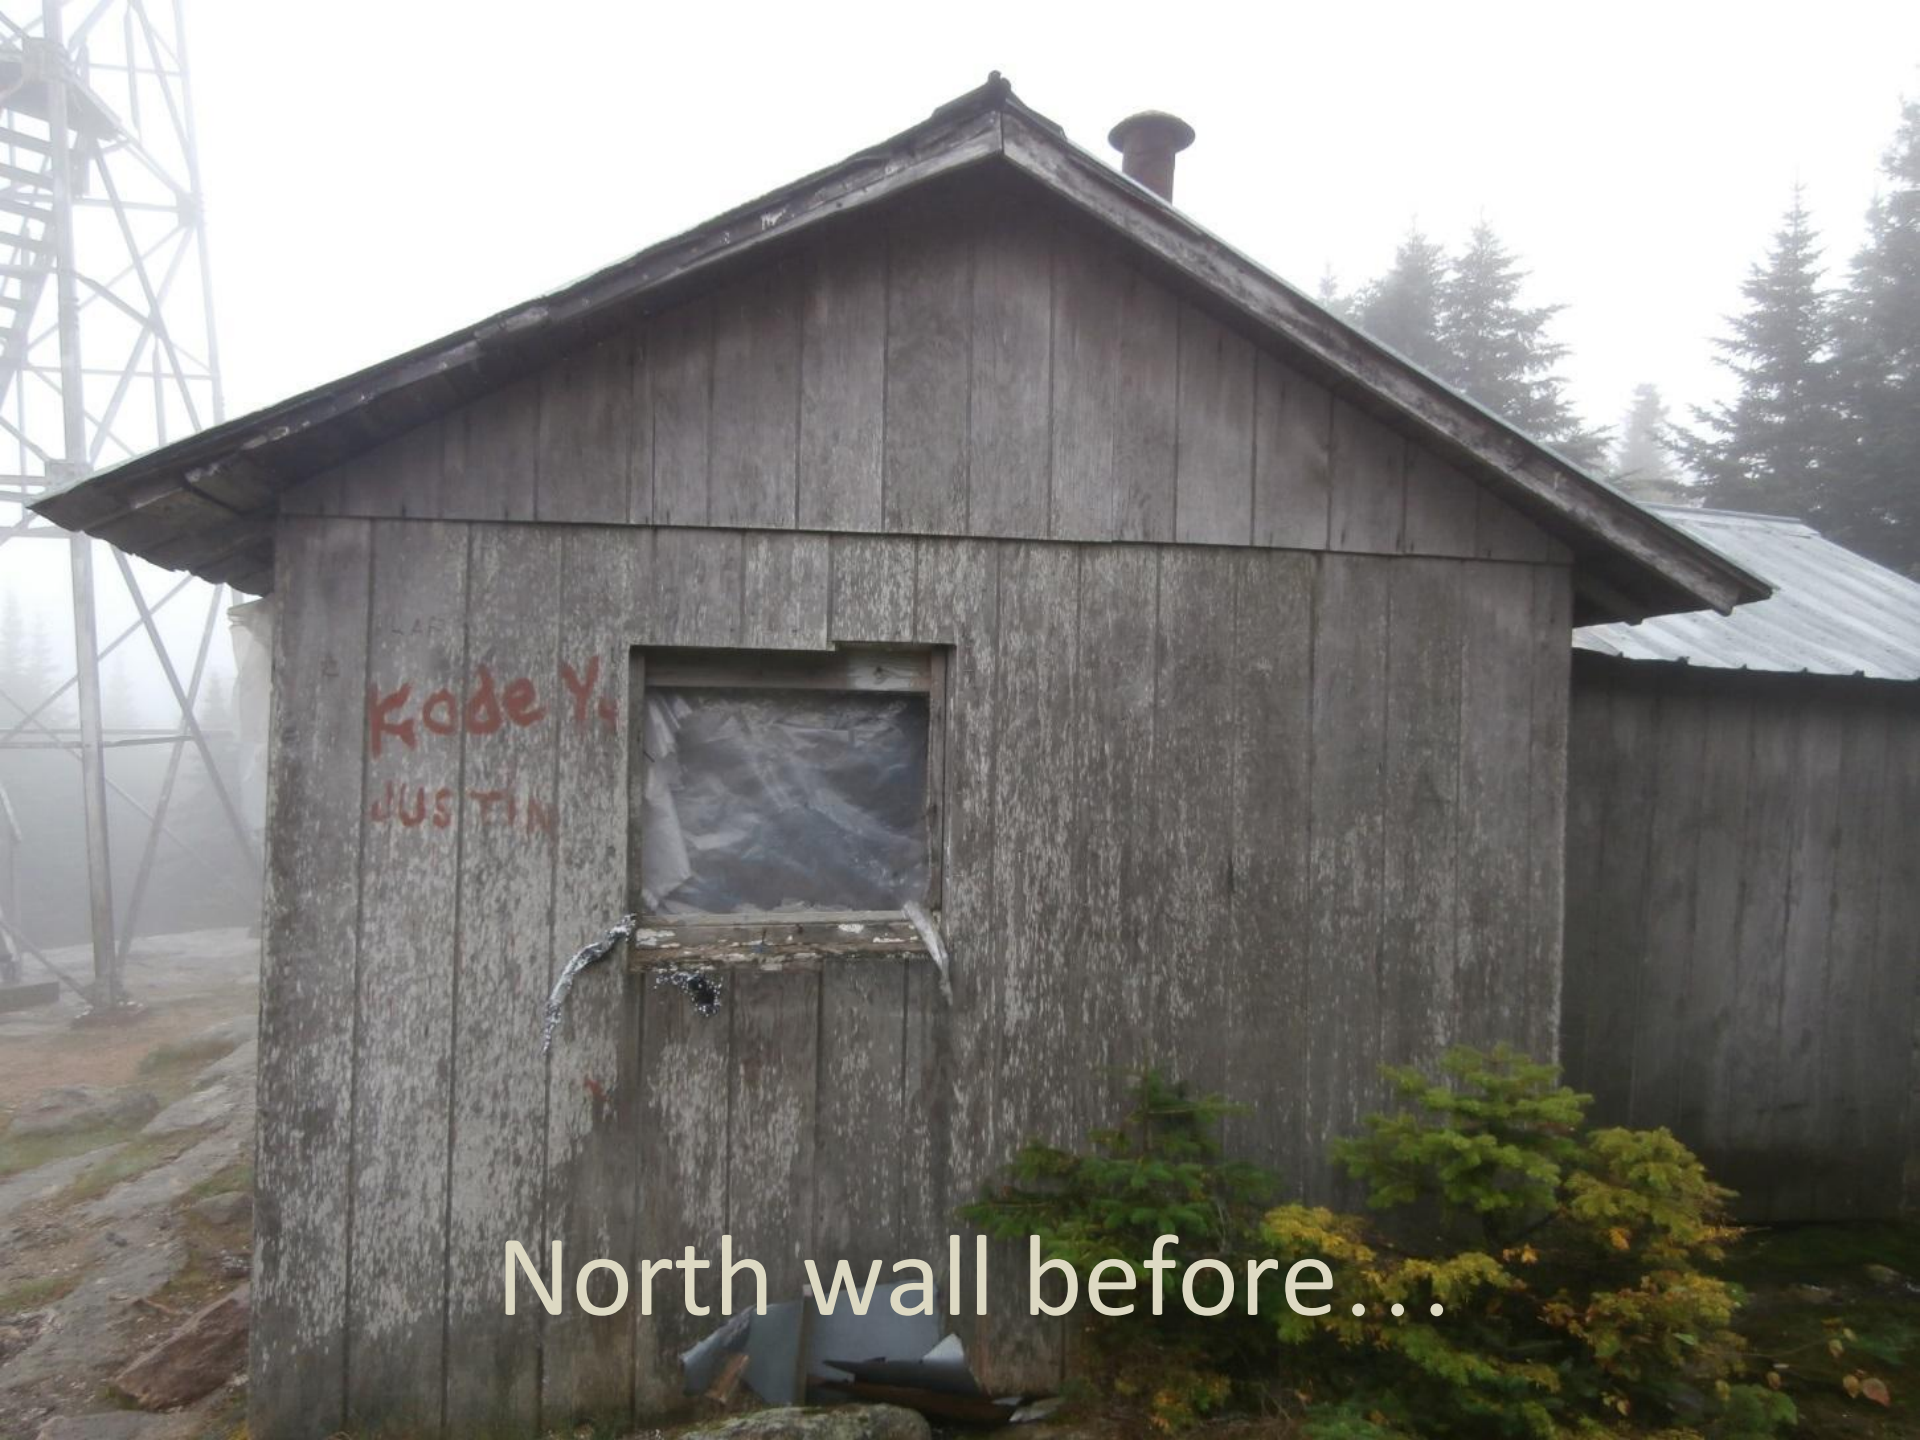
North wall before...

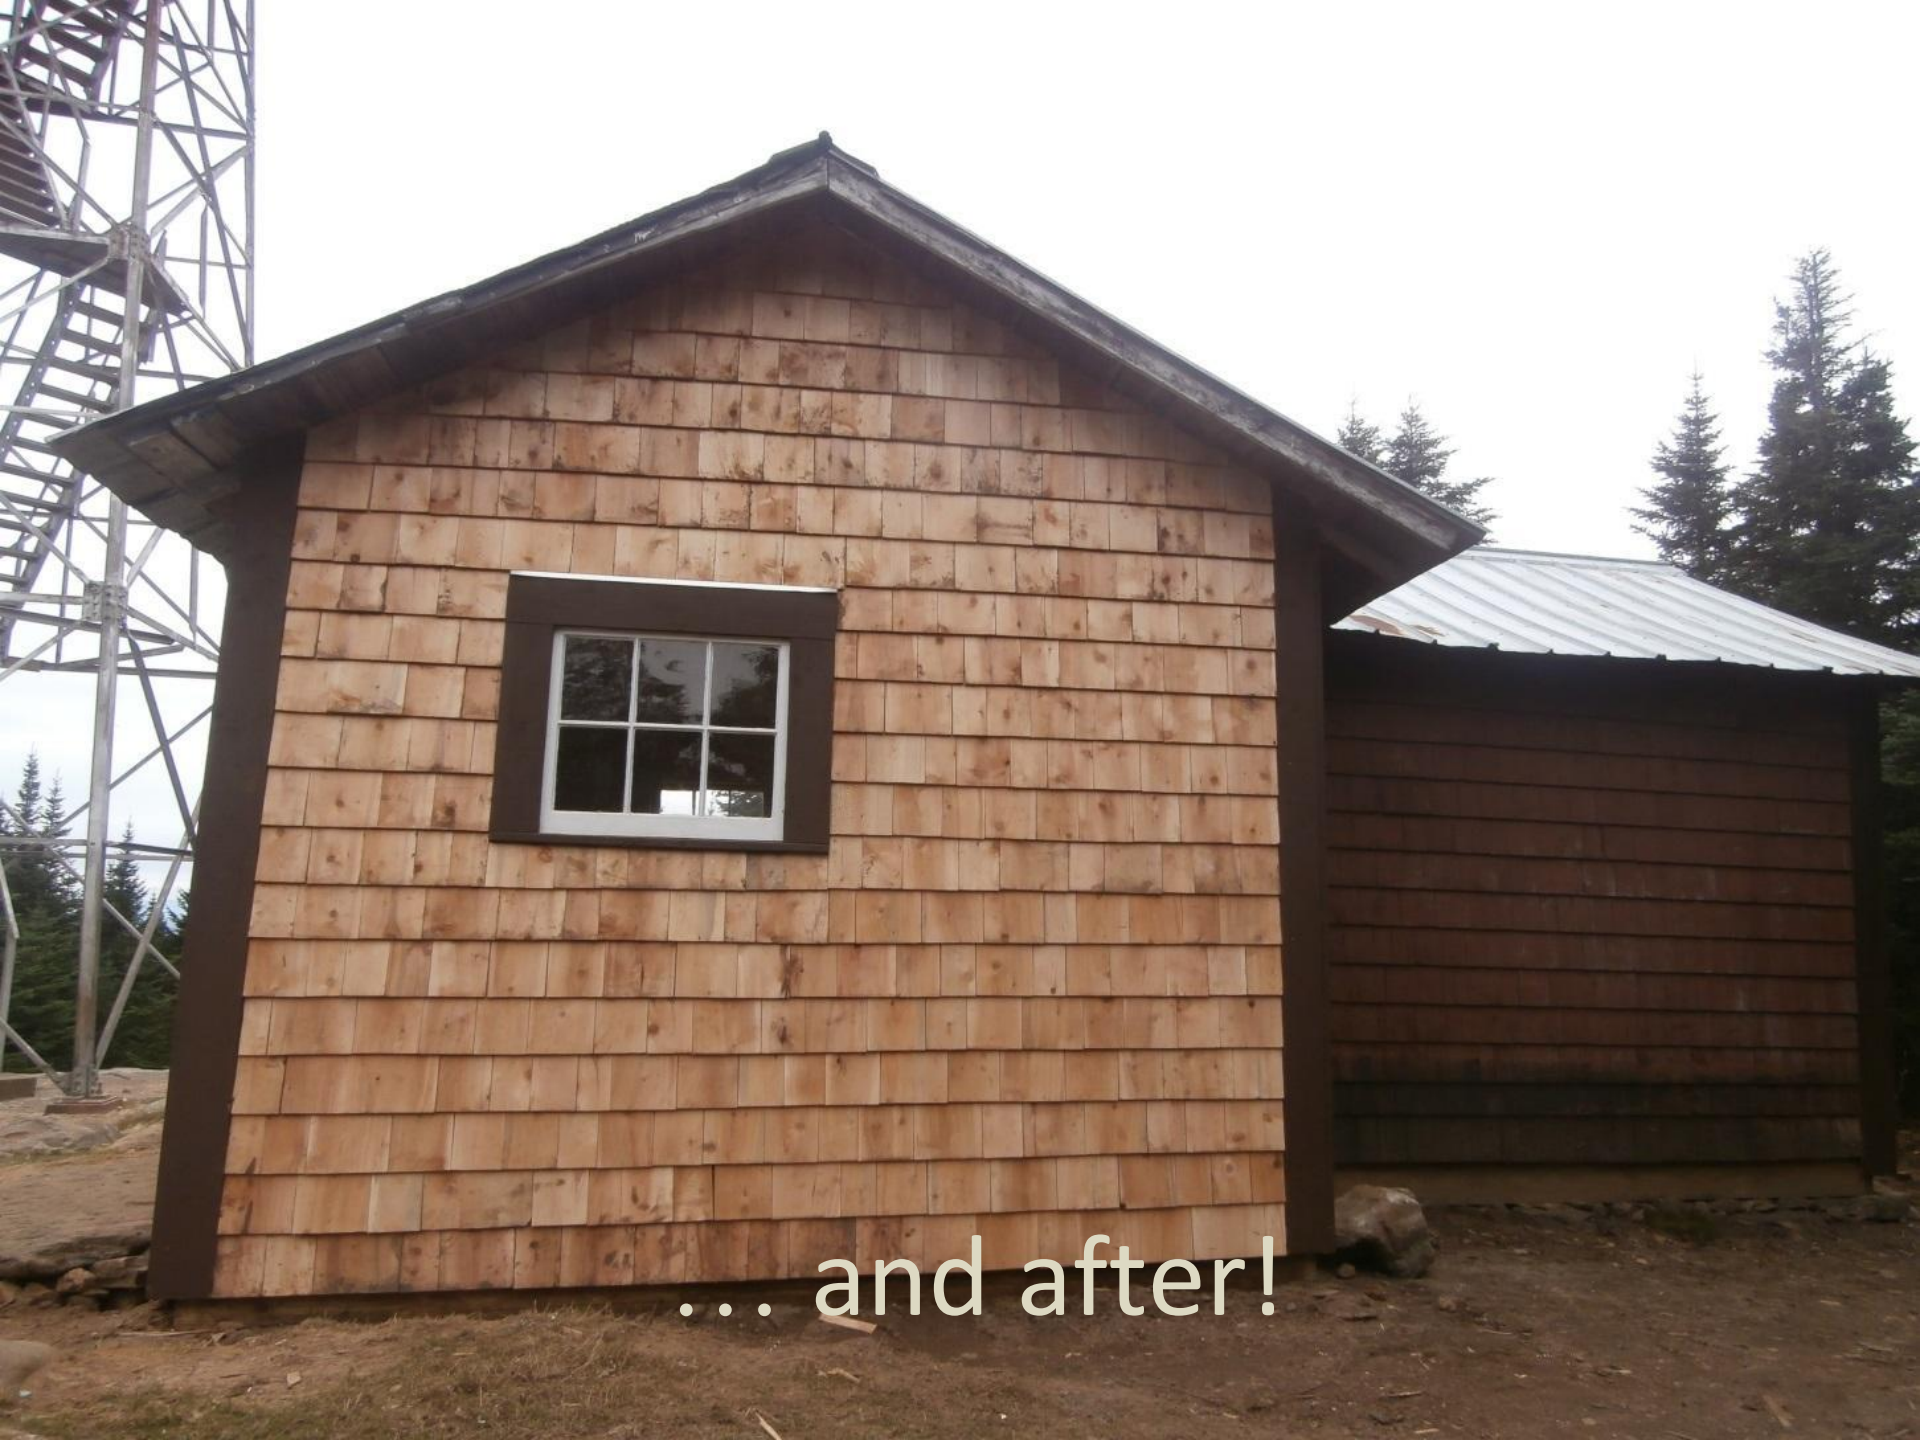
... and after!

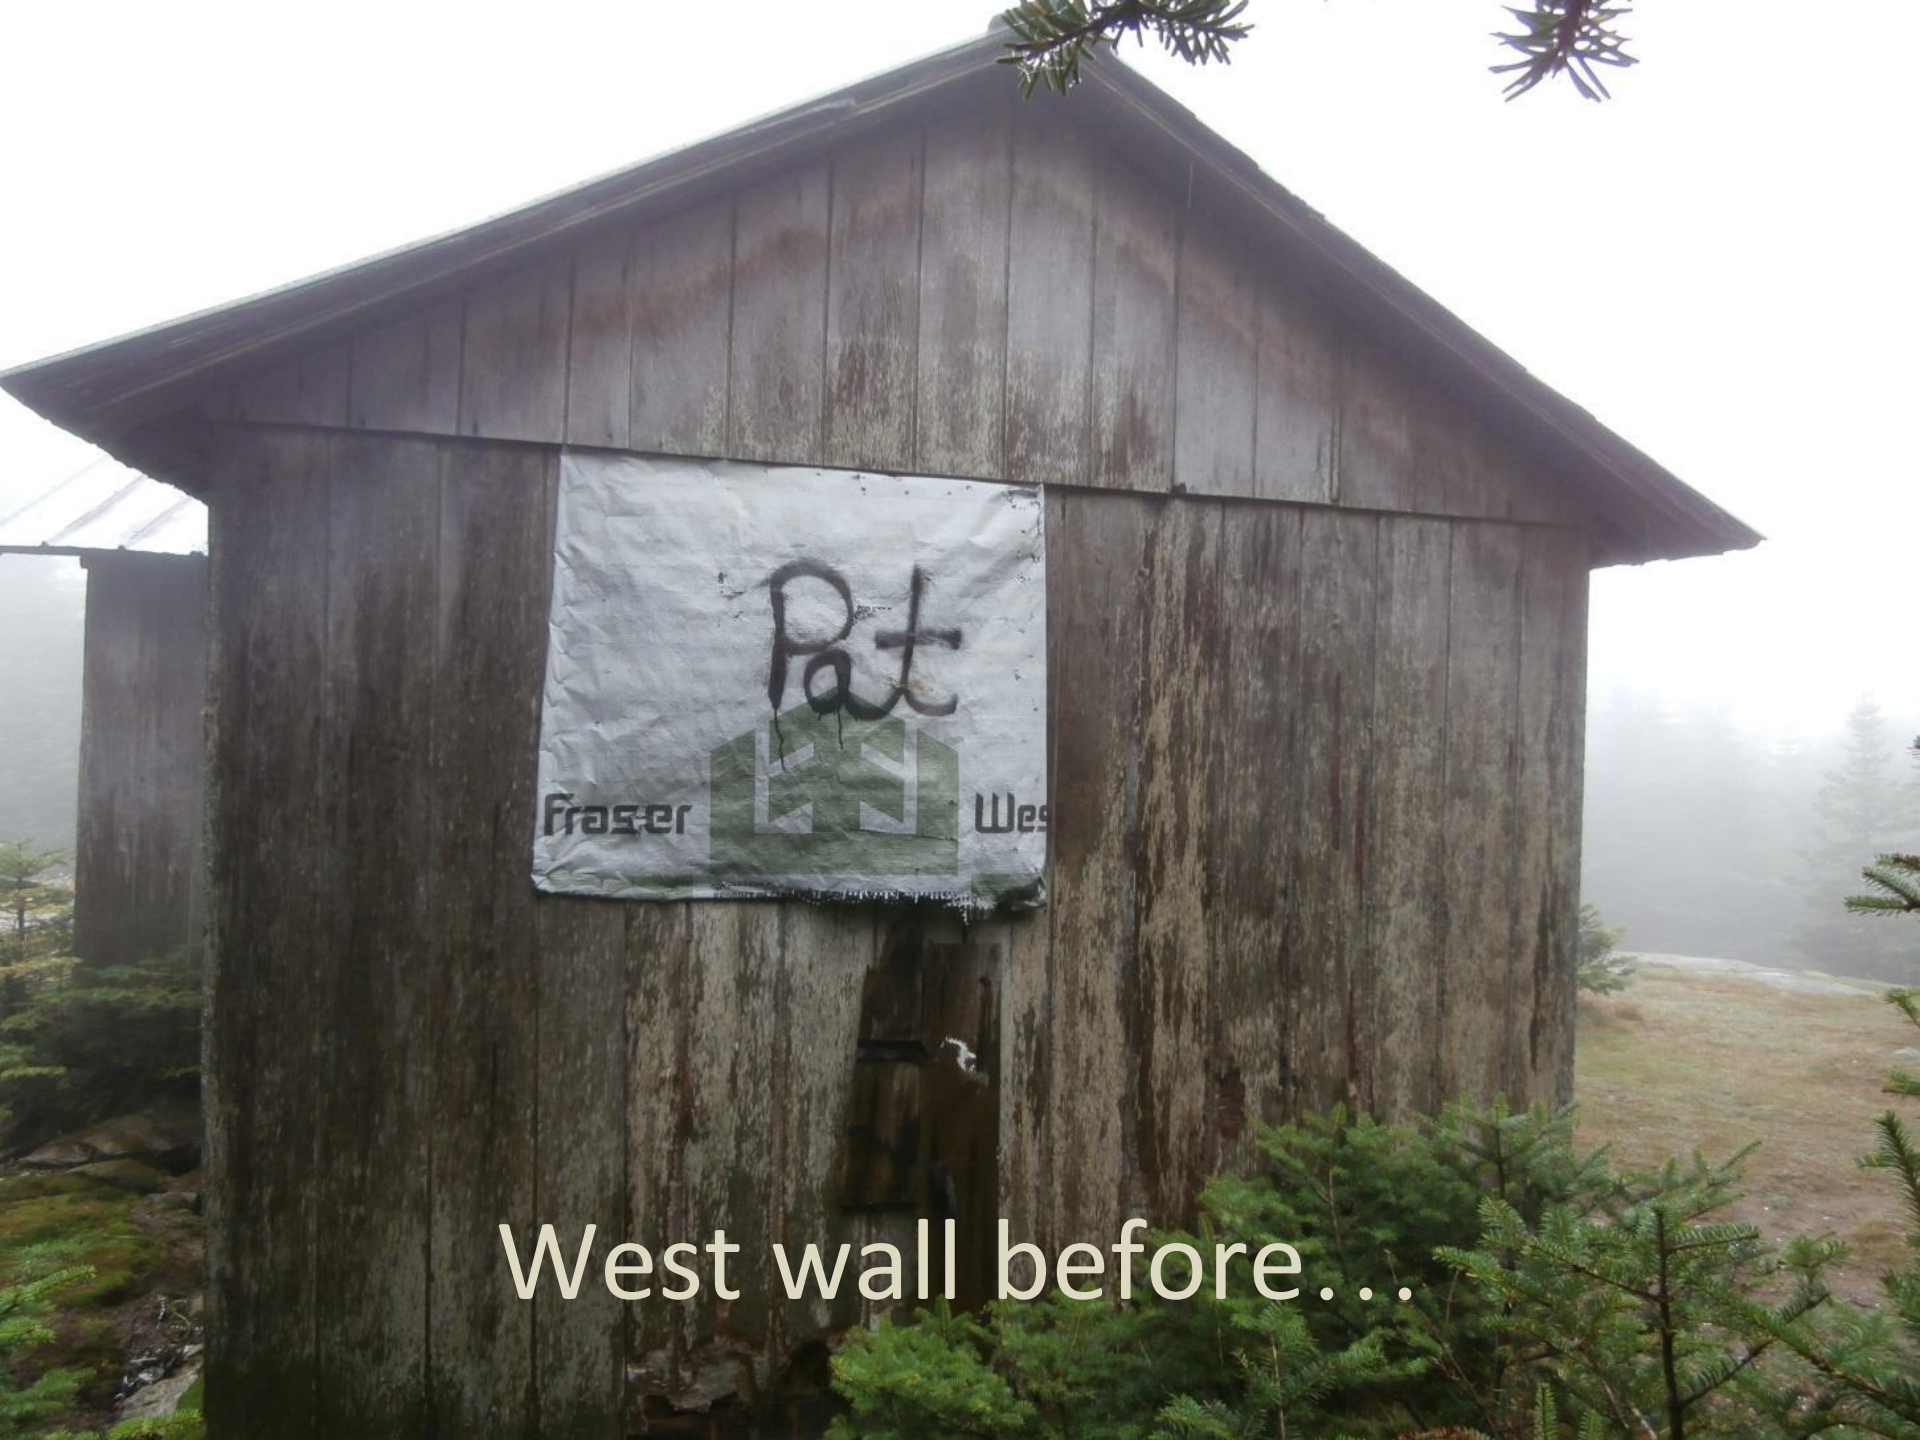
West wall before...
