Bald Mountain Fire Lookout's Cabin

Willoughby State Forest- Westmore, VT
September 9- October 4, 2013

Bald Mountain Cabin, constructed c. 1922

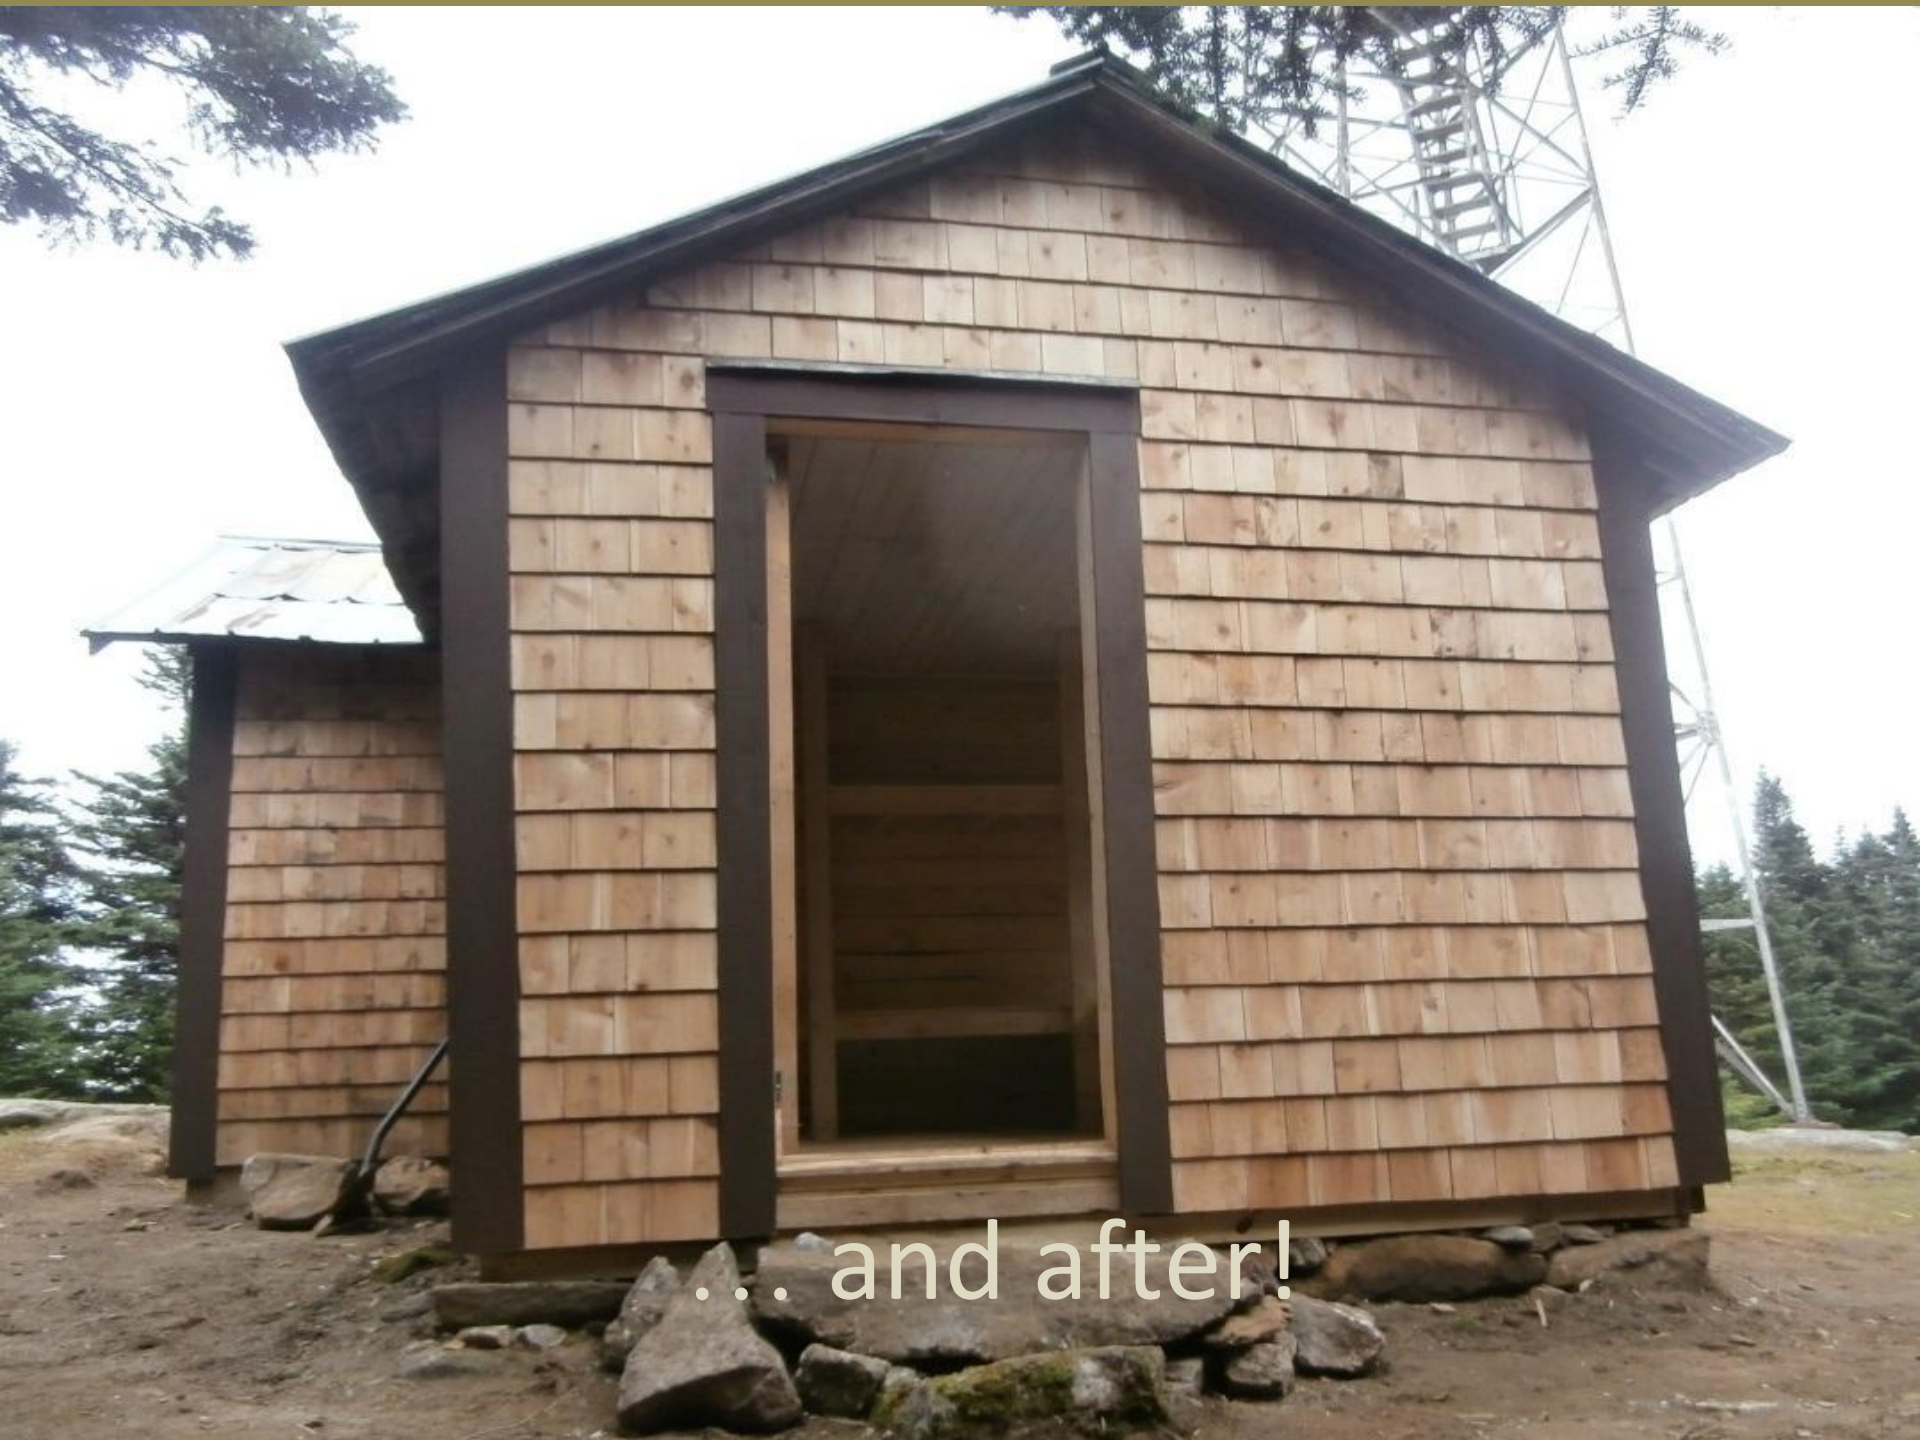
... and after!

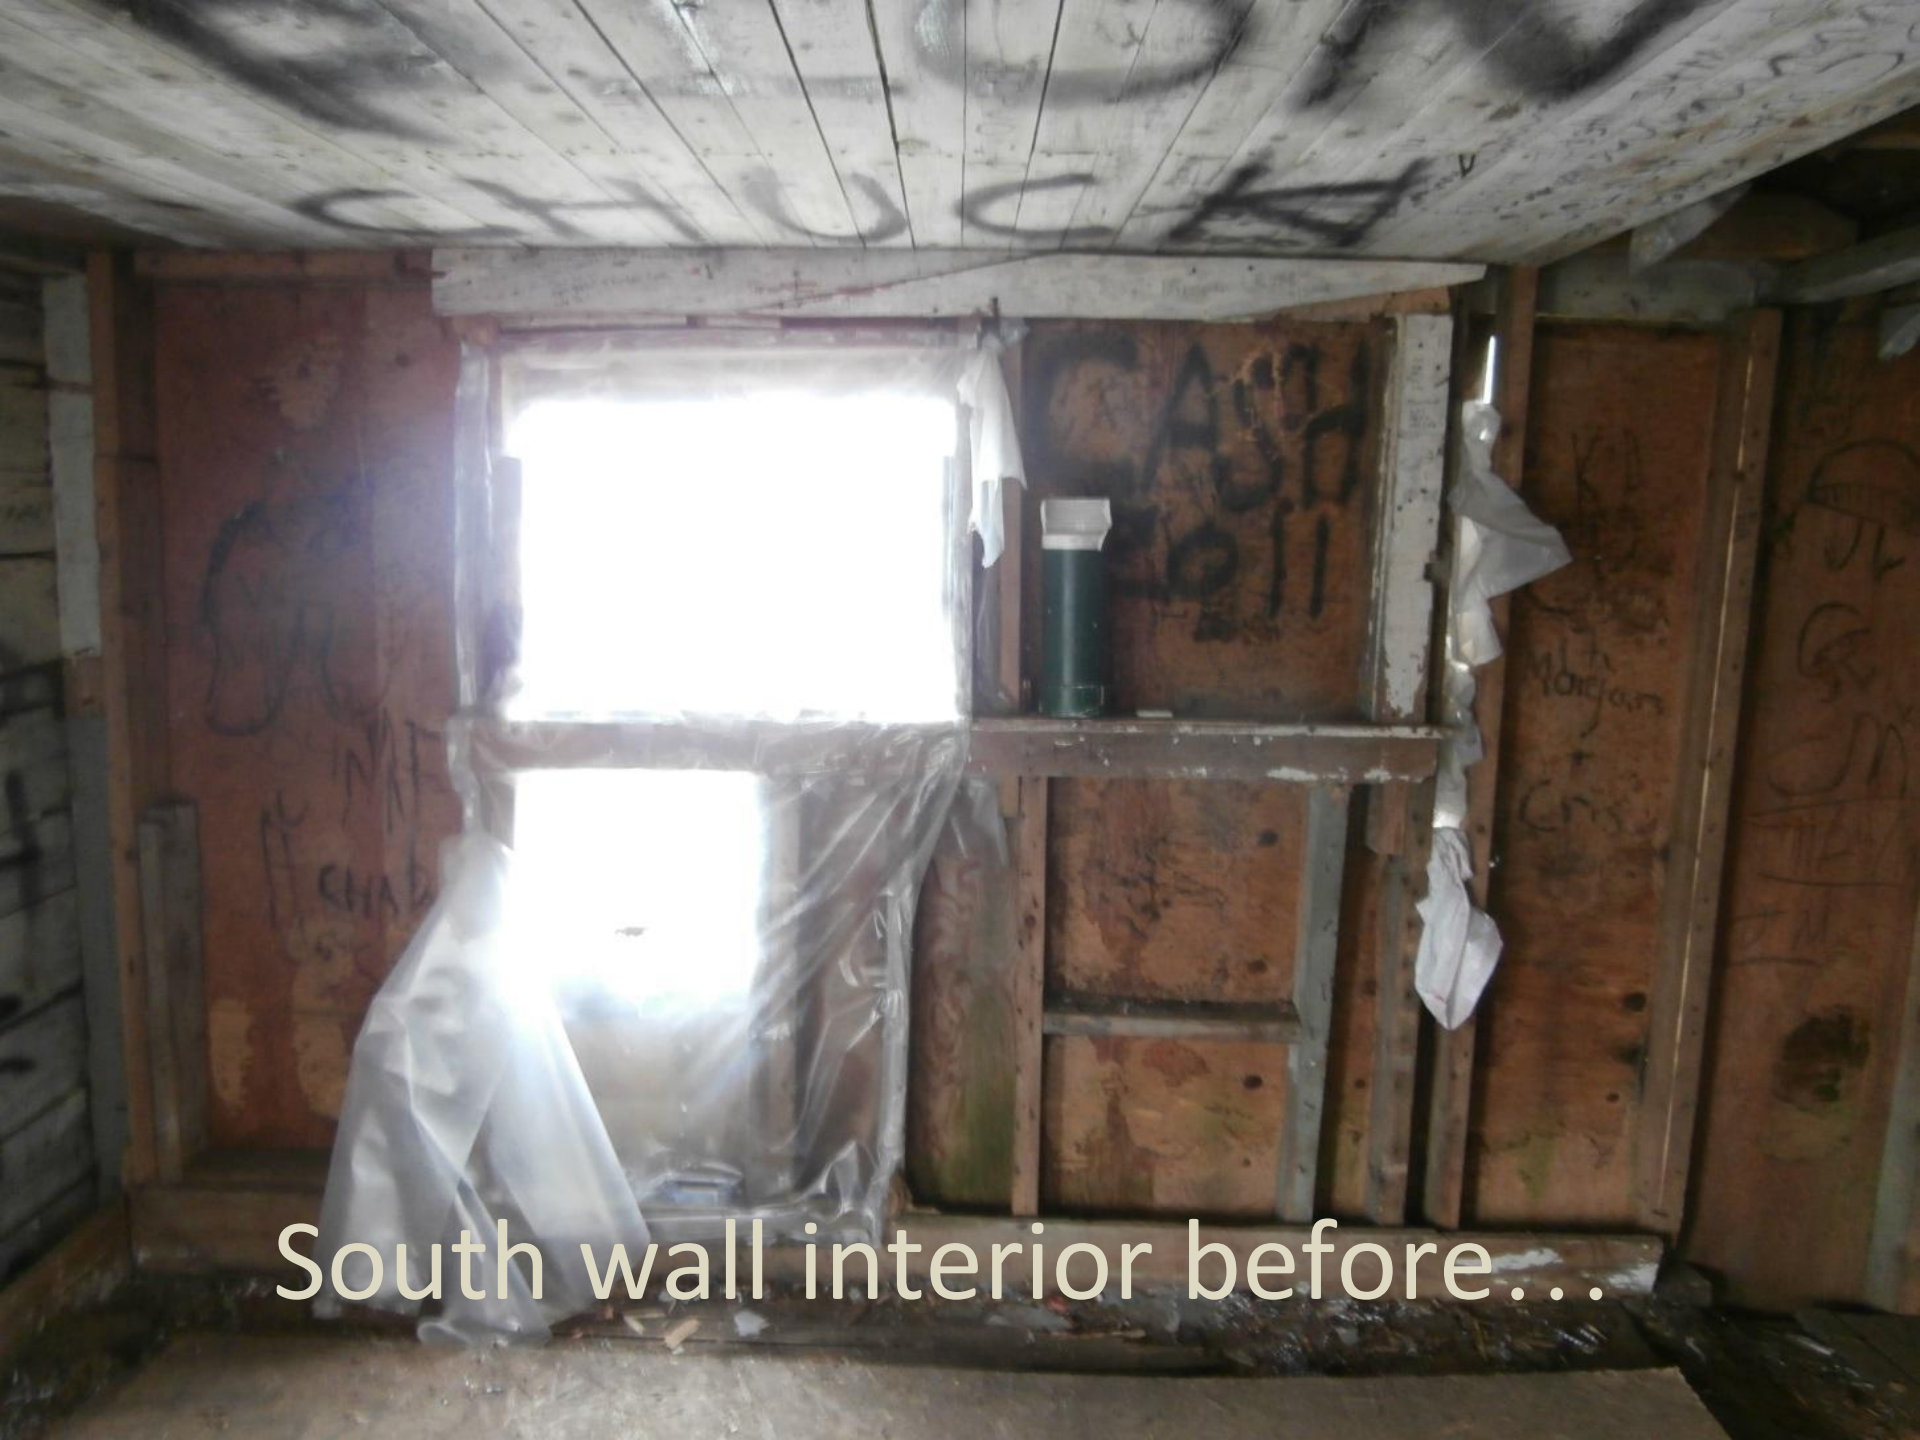
South wall interior before...

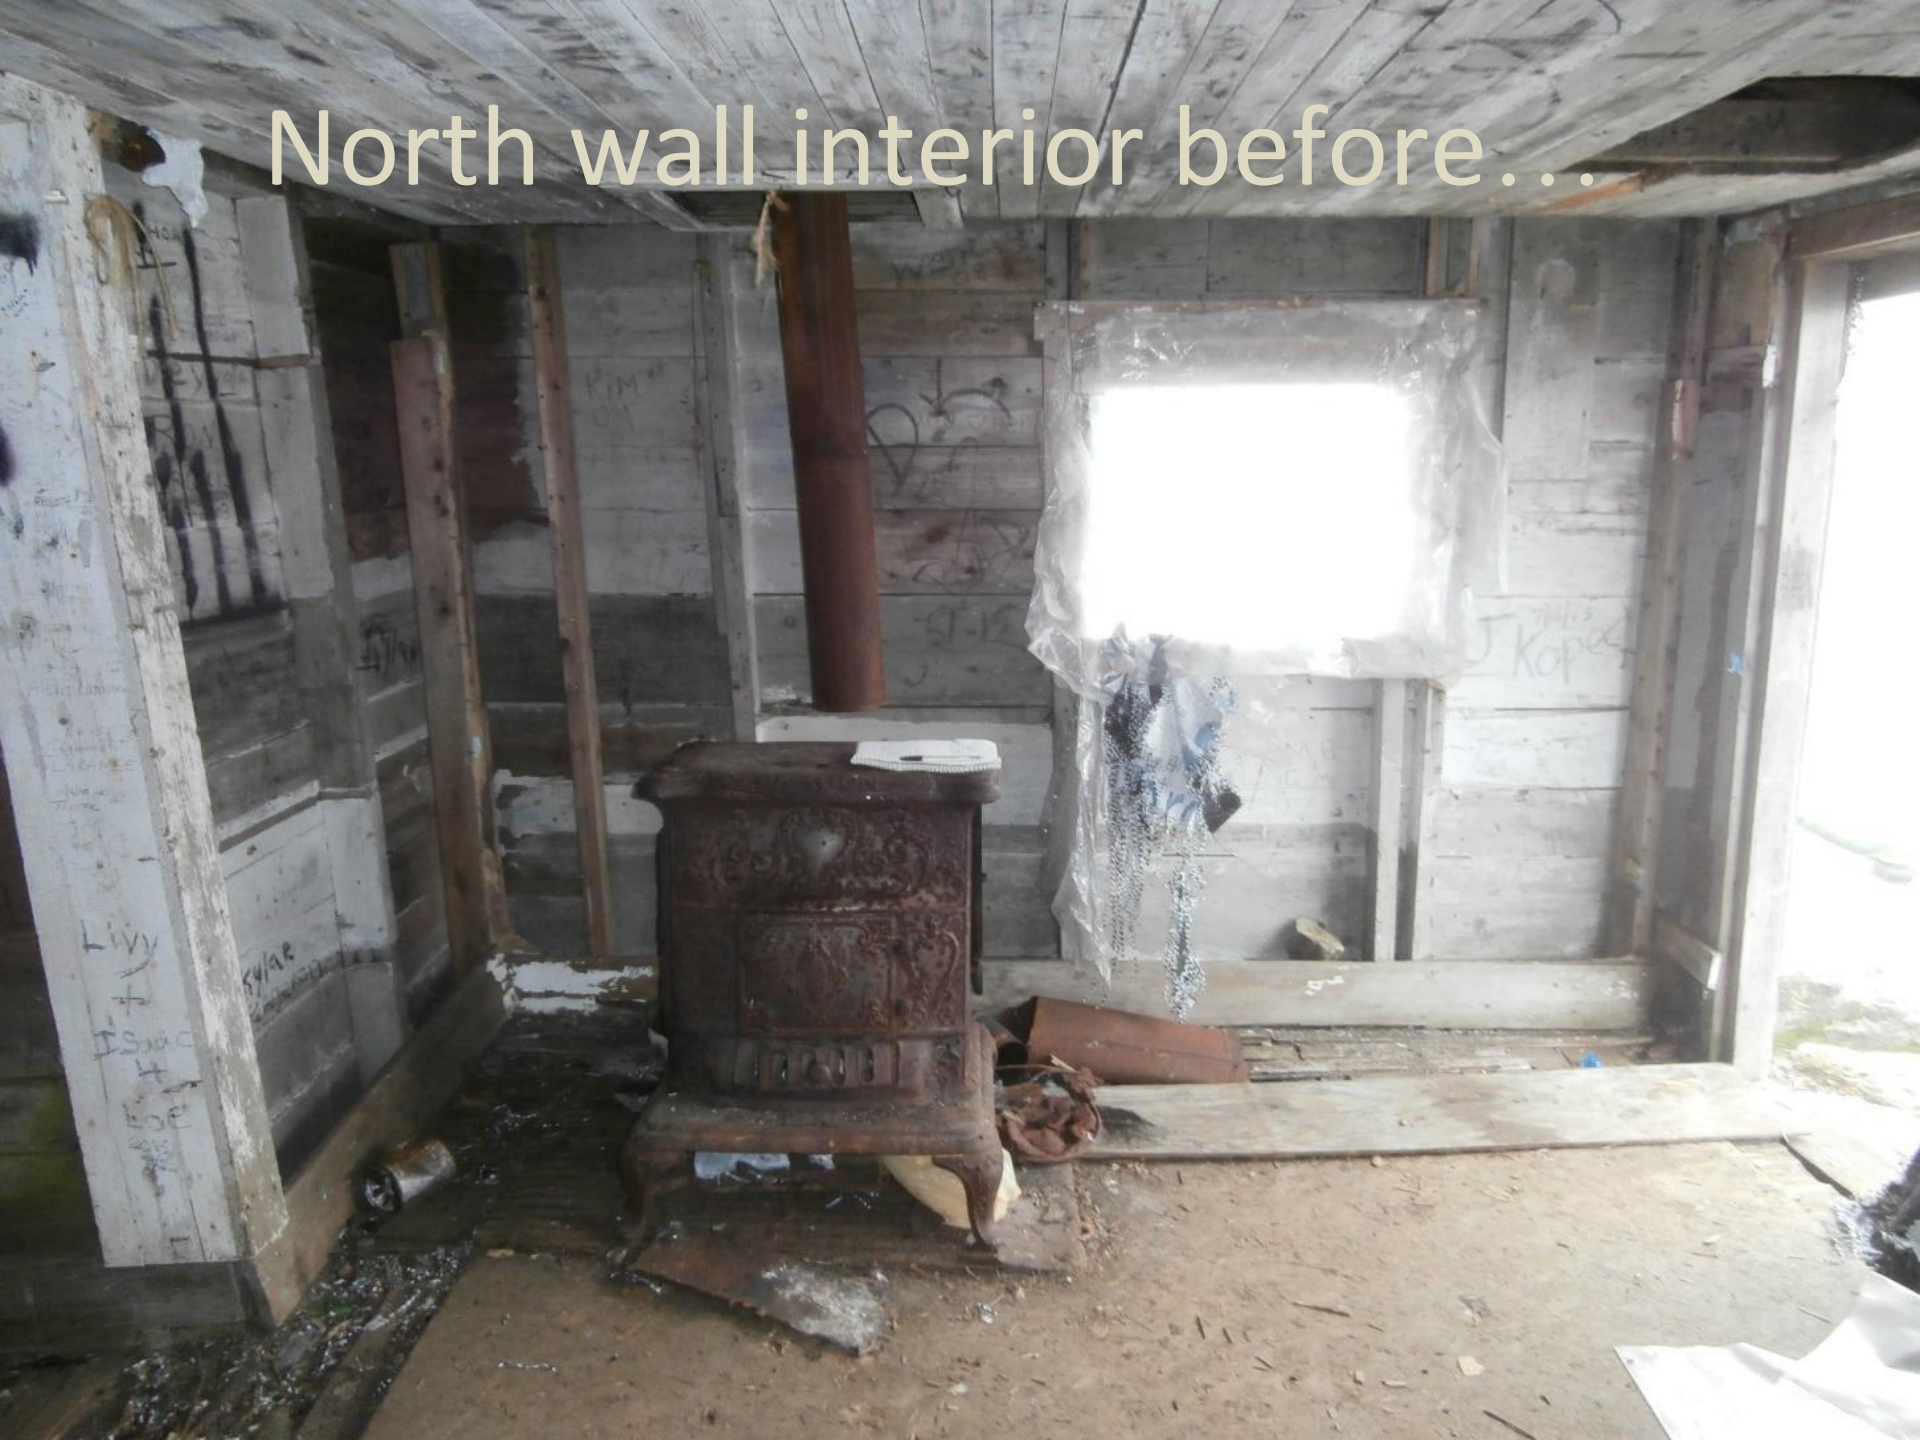
North wall interior before...
